HISTORIC STRUCTURE REPORT

I. G. BAKER RESIDENCE

1600 Block of Front Street
Fort Benton
Montana

BY
SIEVERT & SIEVERT CRC
MAY 30, 2019

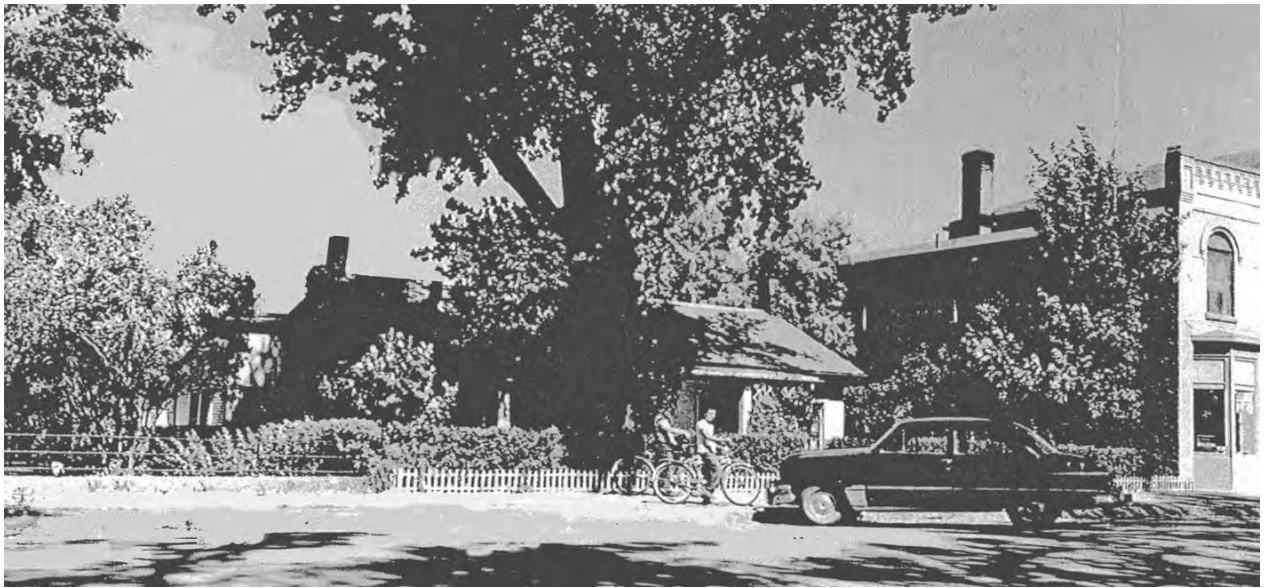
HISTORIC PHOTO

This photograph is attributed to 1950 +/- based on the model of Ford automobile in the image. The chimney on the South end of the roof ridge is visible in this photograph; the brick chimney is related to the 1876 marble fireplace in the South parlor and it is recommended that it be reconstructed.

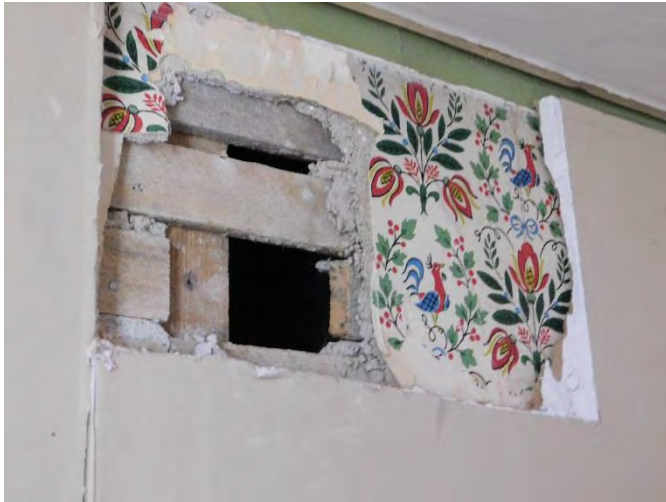
During inspection the west wall of the Kitchen / Utility room 104 was opened up to reveal that the wall had been furred out during the period of occupancy of the house.

Behind the furred wall (that was constructed of plaster and lath) the original wall was found and the original wall has 1st campaign wallpaper applied to it. That wallpaper should be carefully removed in a panel large enough to preserve an entire pattern and the pattern used to make reproduction wallpaper.

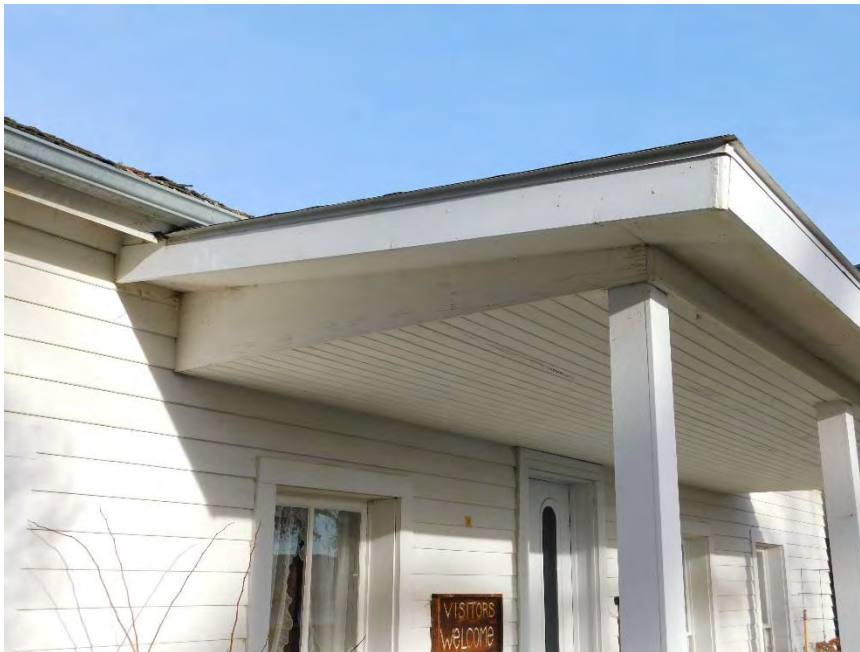
View of the reconstructed porch roof. The style 'K' roof gutter is not period appropriate, and the metal edge trim along the roof is an adverse visual element. The painted wood soffit conveys the historic appearance and is in good condition.

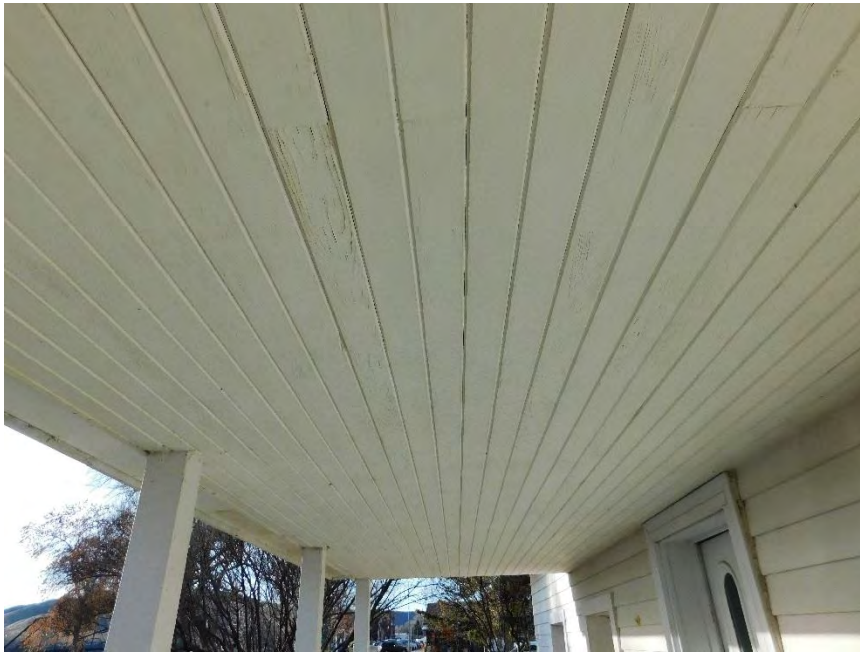
Close-up view of the porch ceiling / soffit. The surface needs to be prepped and re-painted; however, the substrate does not exhibit any areas of failure or deterioration and additional work is not anticipated for this surface.

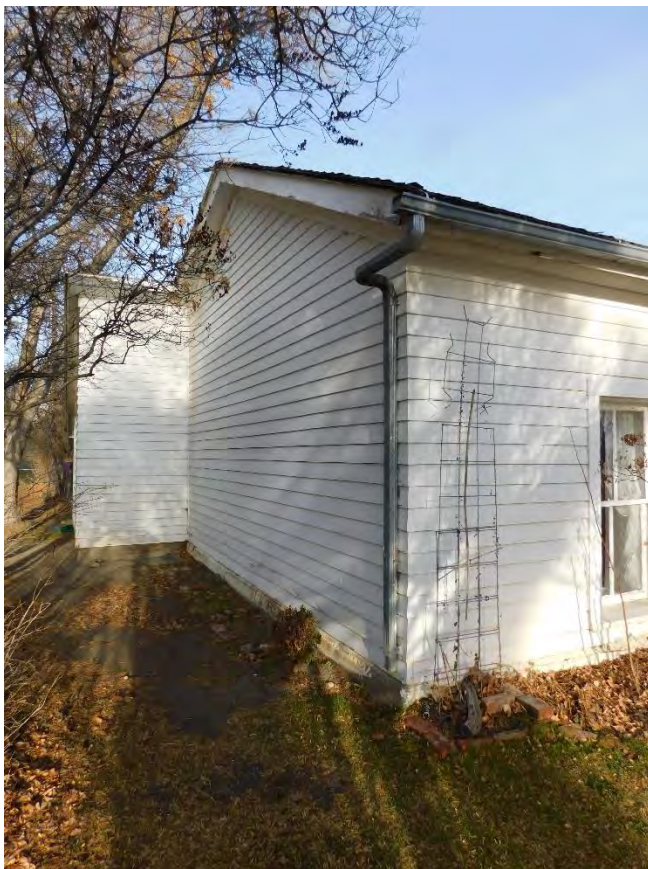
The style 'K' roof gutter, transition, and leader detract from the historic character of the residence and it is recommended that they be replaced with circa 1870 drainage features. It is not known if the structure ever had drainage elements during the period of significance.

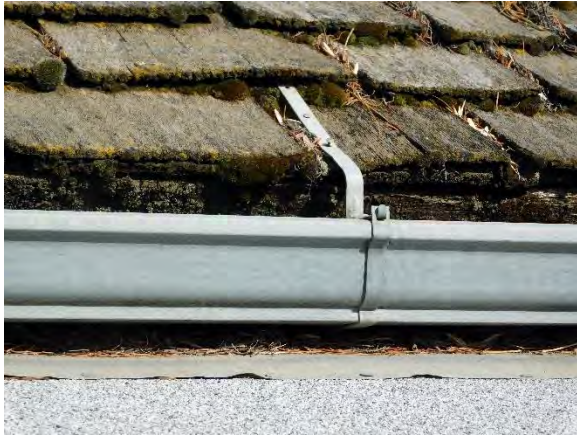
Gutter above the porch roof at the intersection of the porch roof with the east wall. Note the use of mineral surfaced roll roofing above the porch and the condition of the wood shingles.

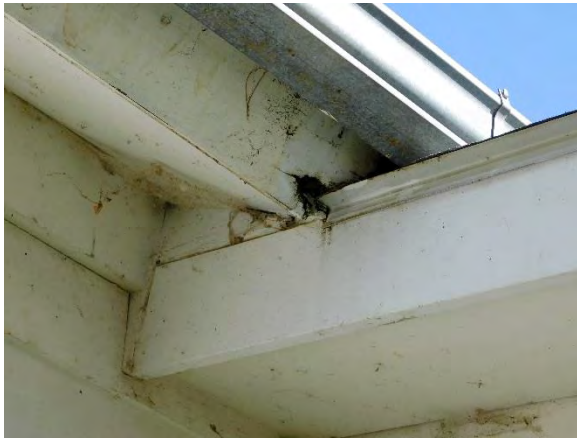
Intersection of the Porch roof fascia and the fascia of the primary roof over the residence. Note the 'D' style metal roof edge (contemporary) along the porch roof.

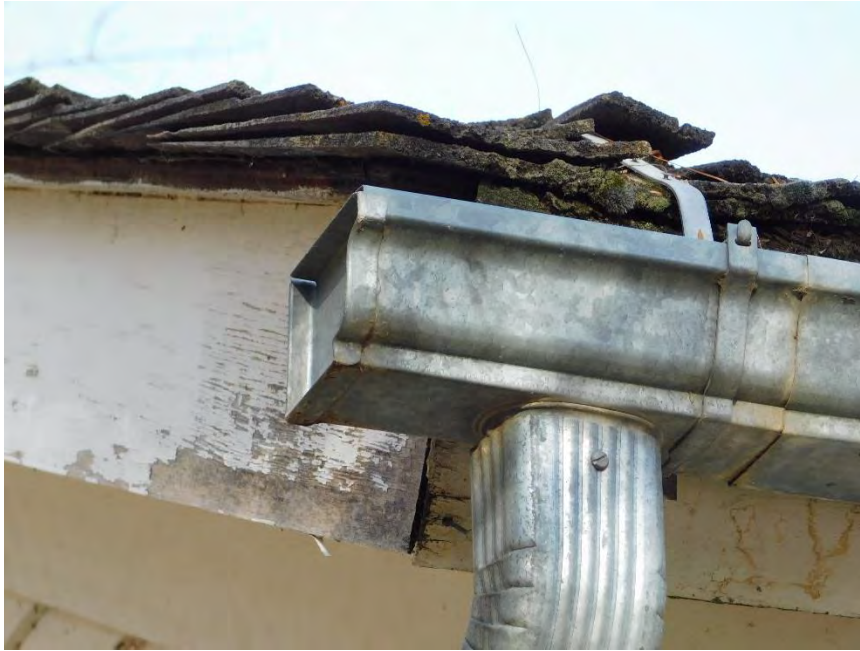
Detail at the edge of the roof at the SE corner of the house. The roof is in need of replacement, the fascia requires prepping and painting, and the mitered fascia corner would benefit by application of a sealant.

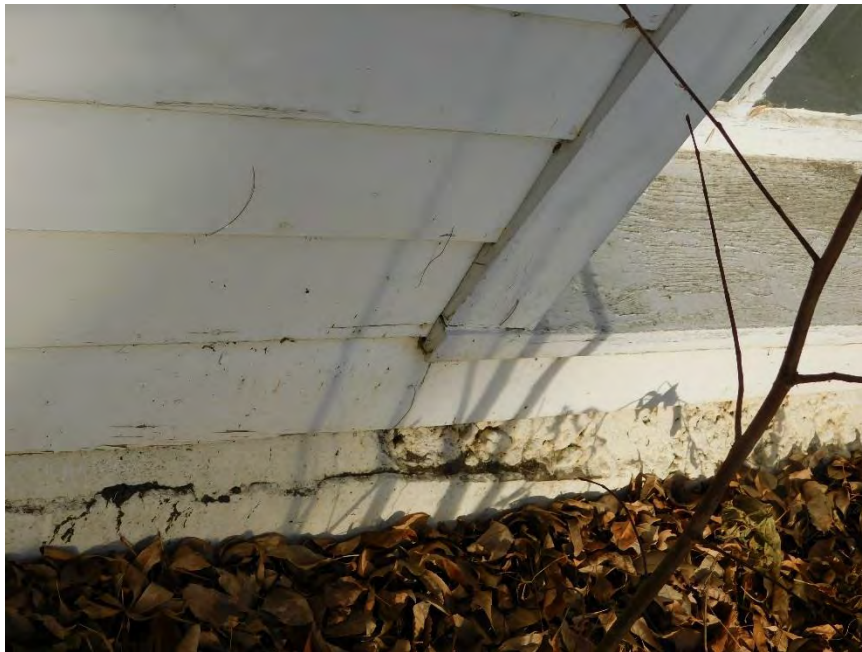
Failed section of the 1973 weatherwall adjacent to the SE corner of the residence. Note that this location coincides with the crack pattern in the interior wall finish of the 1876 Parlor.

- Stabilize SE corner of the residence that has failed.
- Brace roof ridge to take load off of 1867 roof purlin.
- Introduce stability bracing or realign west wall of Kitchen that is significantly out-of-plumb.
- Complete roof diaphragm of Kitchen ceiling and re-level.
- Mitigate asbestos containing materials as identified within the hazardous materials report.
- Mitigate lead-based paint materials as identified within the hazardous materials report.

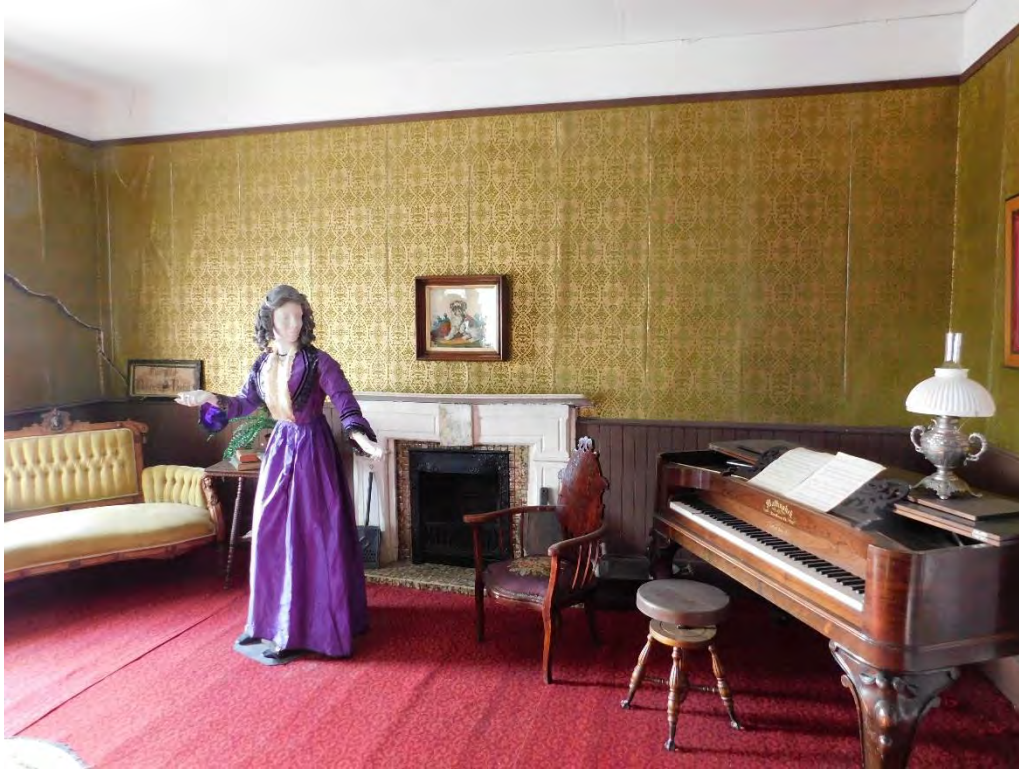
ROOM 103 – SOUTH PARLOR

Looking South; note crack in plaster at left corner. Wallpaper and carpet are from the 1970's; marble fireplace is circa 1876.

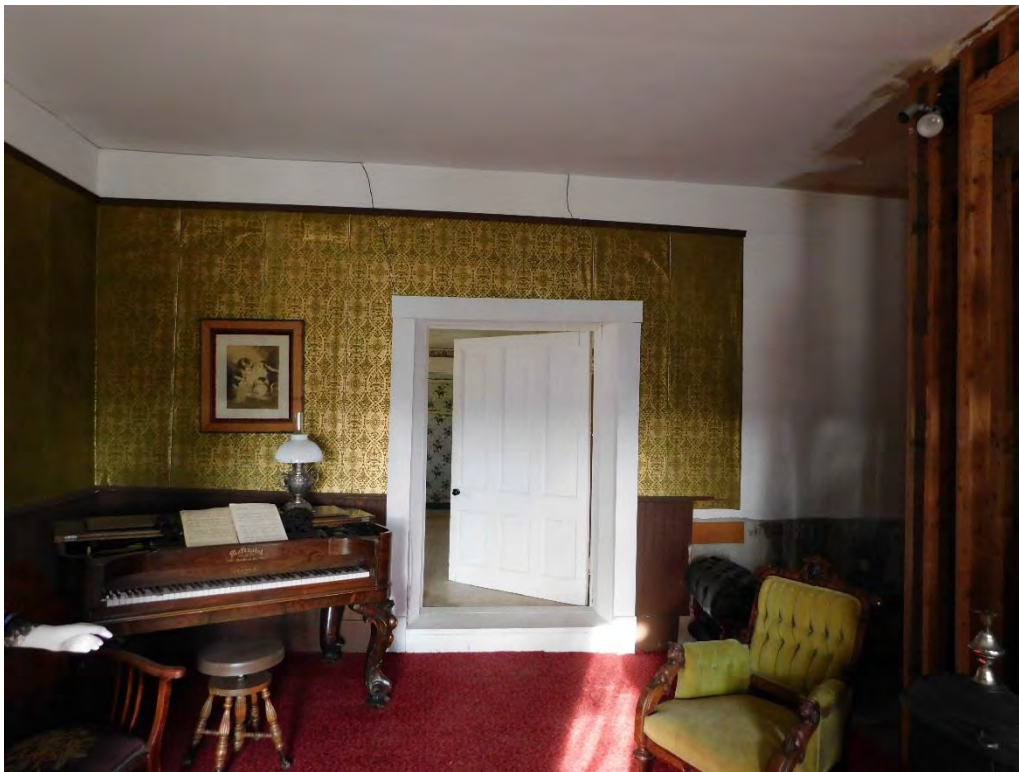
View looking West. Step at door is from floor being lowered in the 1970's. Door is unusually wide (4'). Bare wood studs are not historic.

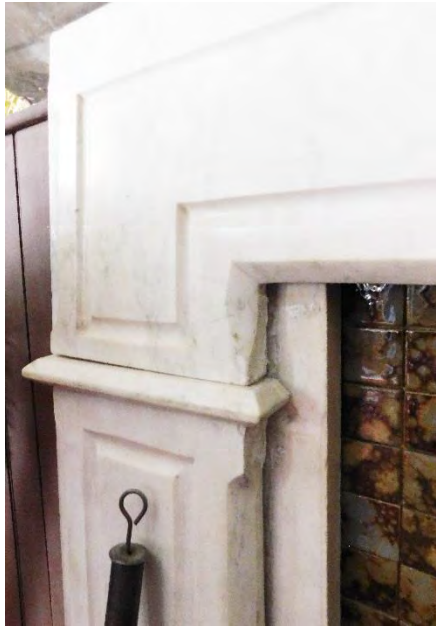
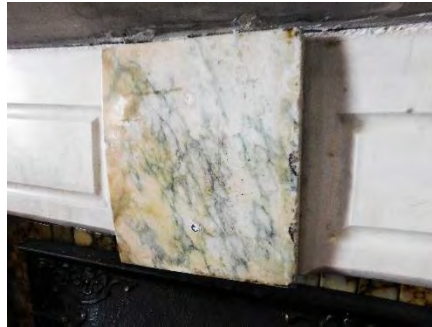
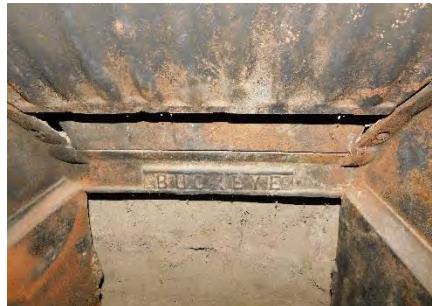
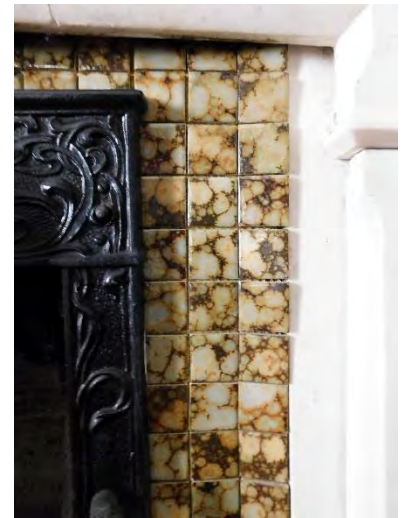
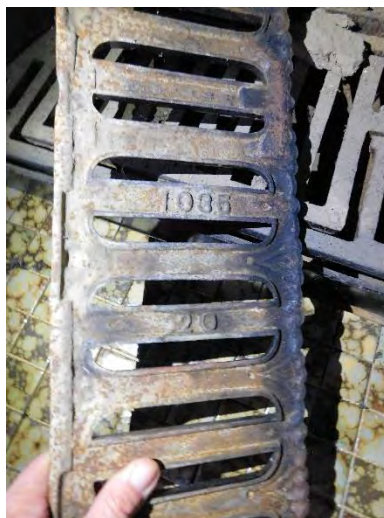
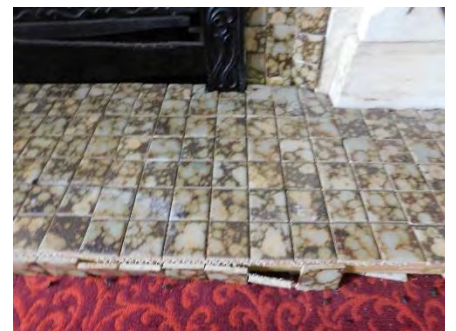
Details of the marble fireplace in Parlor 103; including views of the marble carving, temporary repair at the center of the marble headed, the 1-7/16" square marble tile surround and hearth (replaced in 1973), and the cast iron "Buckeye" fireplace insert.

- Repair marble fireplace.
- Replace / provide wallpaper where damaged or missing (period appropriate).
- Repair or stabilize adobe walls; including whitewash.
- Repair or replace plaster wall finishes that exhibit damage or have been removed.
- Provide dust barrier above existing wood ceilings.
- Provide borate treatment to exposed wood.
- Accommodate concealed electrical along with finishing operations.
- Provide paints / preservative coatings to finished materials.
- Rehabilitate hardware; clean, lubricate, adjust, make operational.
- Replace selected light fixtures with period appropriate assemblies.

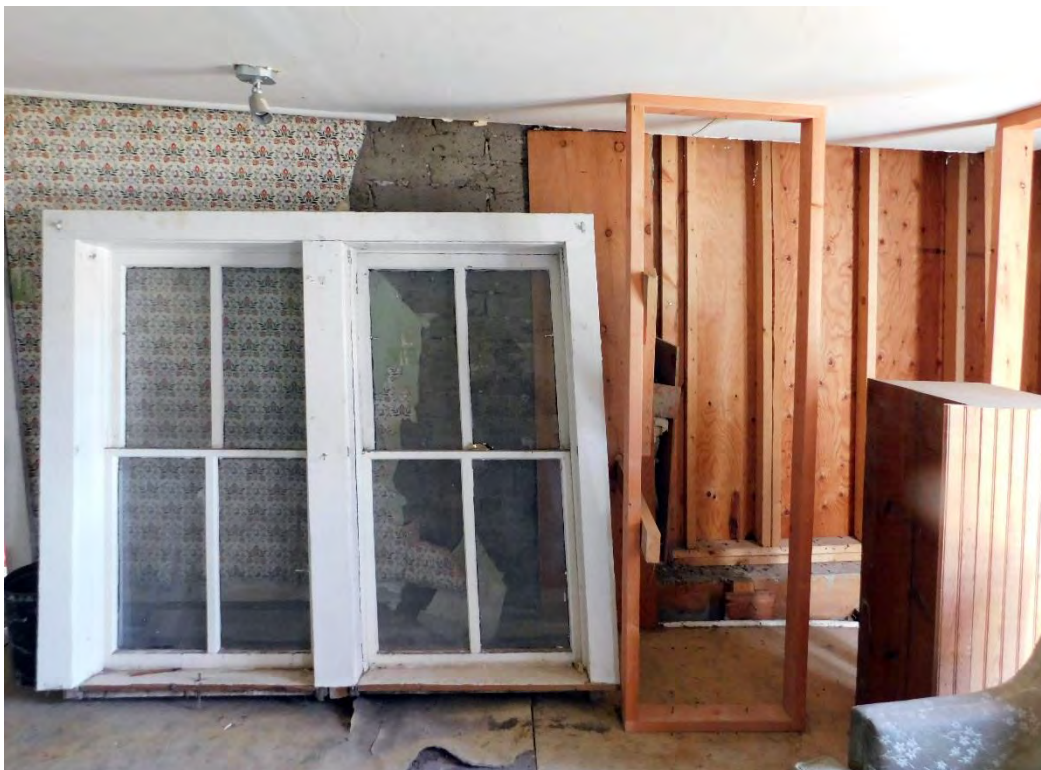
South end of East
wall; the plywood
indicates the
location where the
kitchen offsets
past the plane of
the South wall of
the Parlor. The
offset was
originally built with
brick walls but has
been replaced with
a wood frame wall
in recent years.

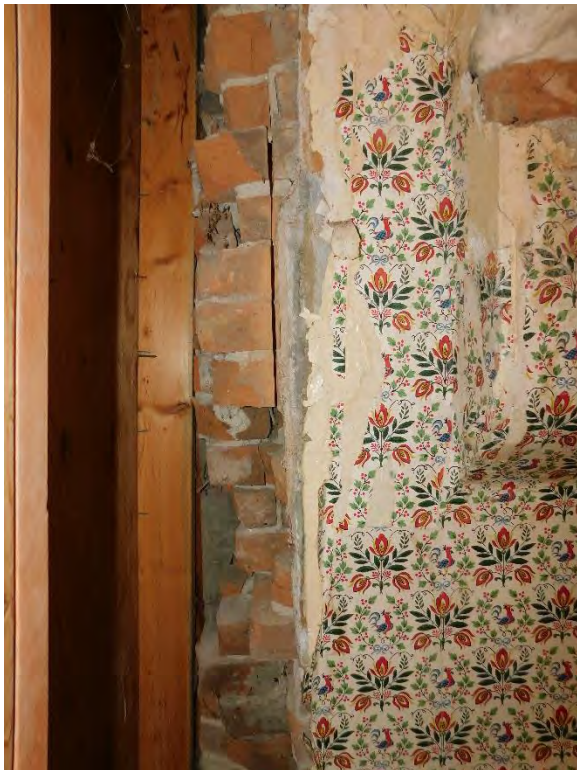
South end of West wall showing where original brick ends and replacement wood frame wall begins.

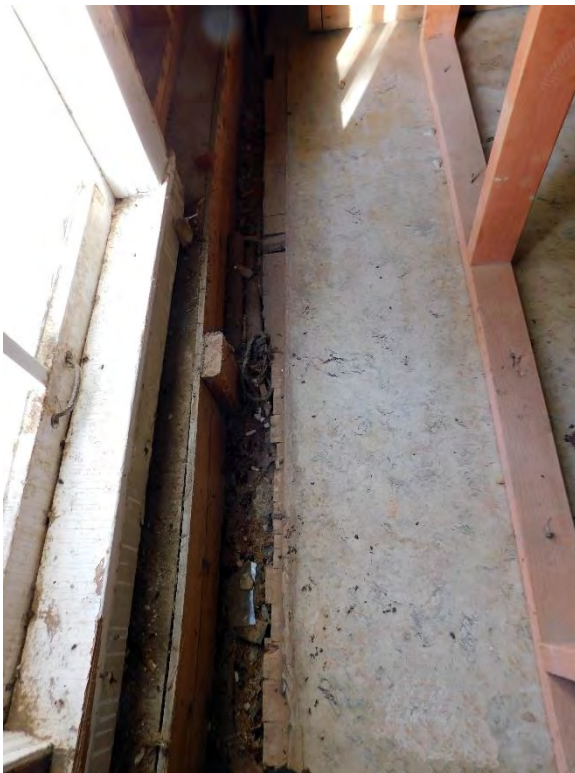
Looking down at base of South wall showing edge and forming of replacement concrete grade beam that supports new wood framed replacement wall. Note the ends of the original T&G fir flooring that can be seen on the right hand side of the gap.

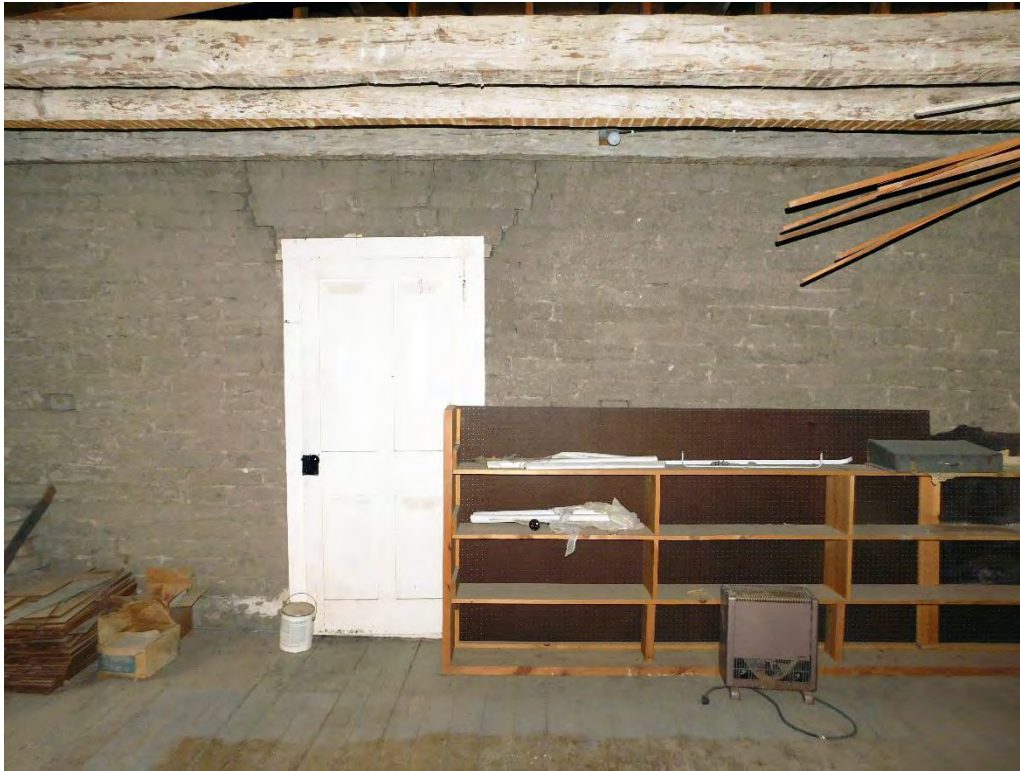
View of East Wall; note crack pattern in original adobe above door. The paint pattern on the bottom of the log purlins suggest that a lath and plaster ceiling may have finished the ceiling at one time in the structure's history.

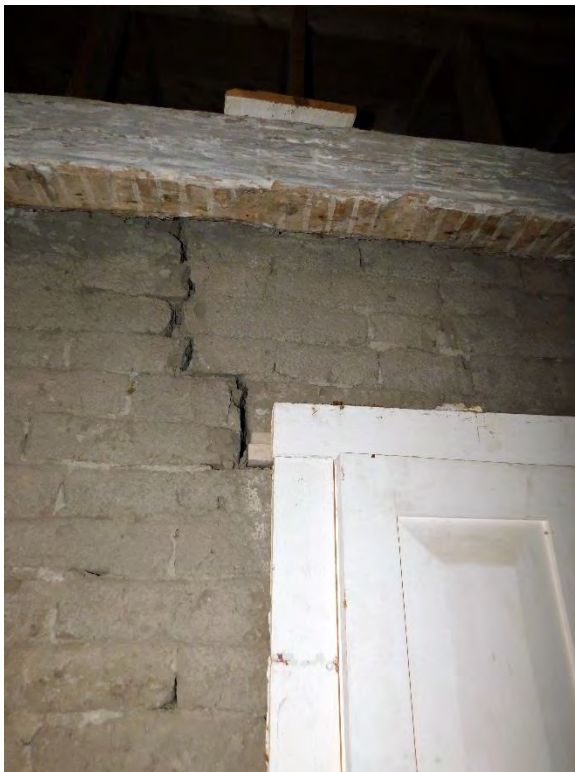
Closer view of the crack above the North edge of the door into Room 102. The void above the log burlin occurs between the upper and lower roof systems and allows for access into the attic space above Parlors 102 and 103.

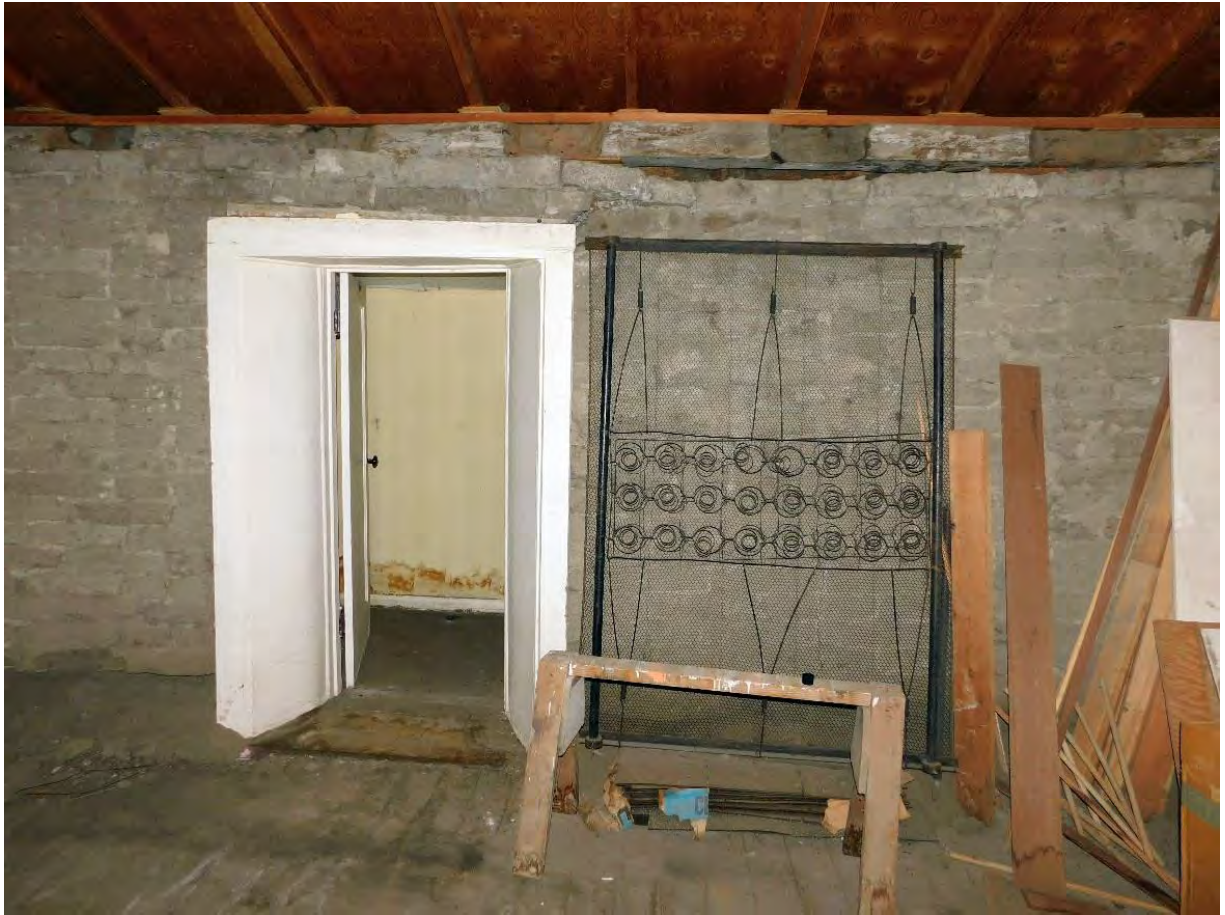
View of West Wall; note wood infill at top of original adobe on the right side of the door.

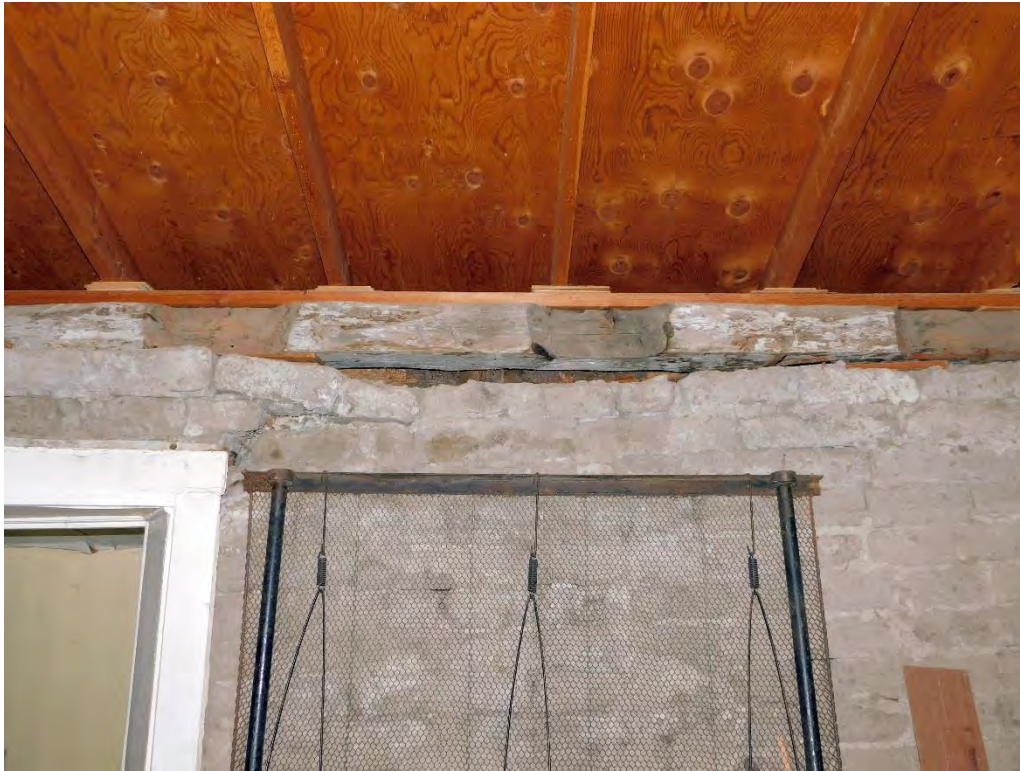
Closer view of repair at top of section of the West Wall.

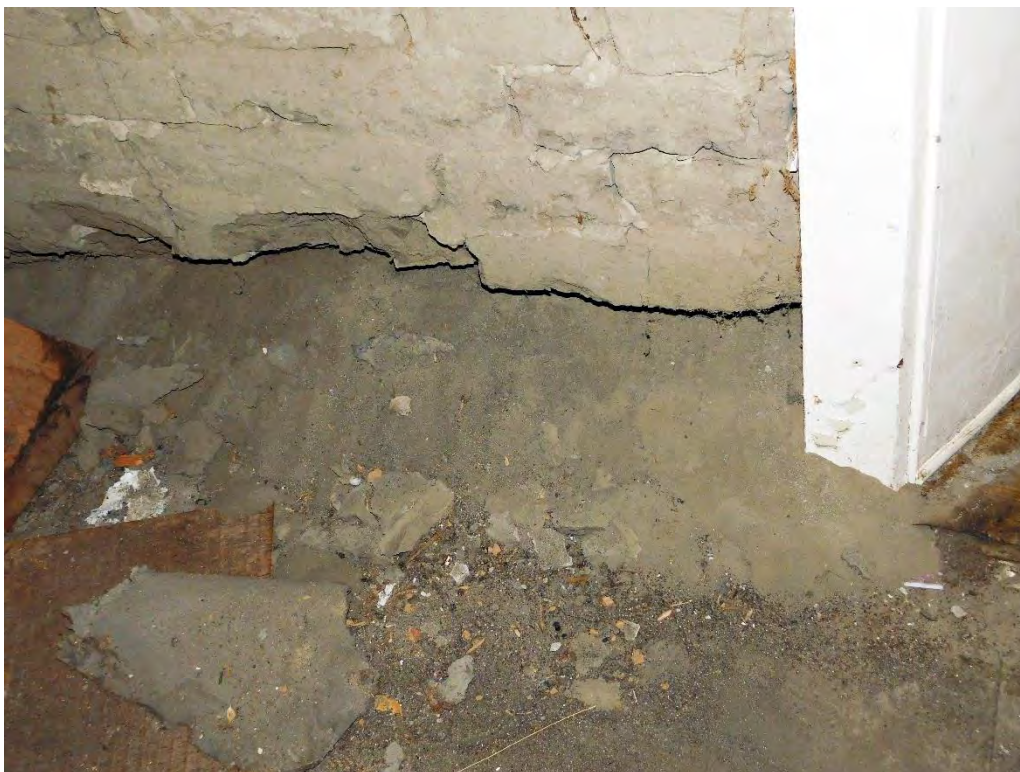
The adobe at the base of this wall exhibits substantial erosion. Refer to comments within the materials section of this HSR.

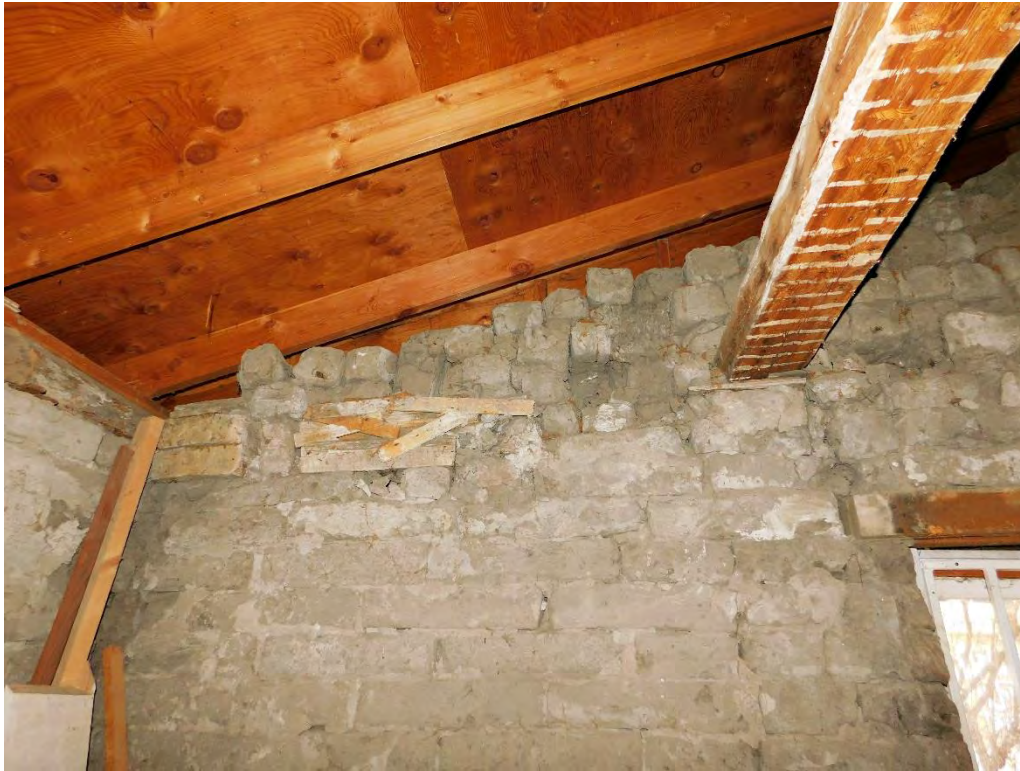
View of the upper part of the North wall; note the random size adobe blocks used to repair the top of the wall when the roof line was changed.

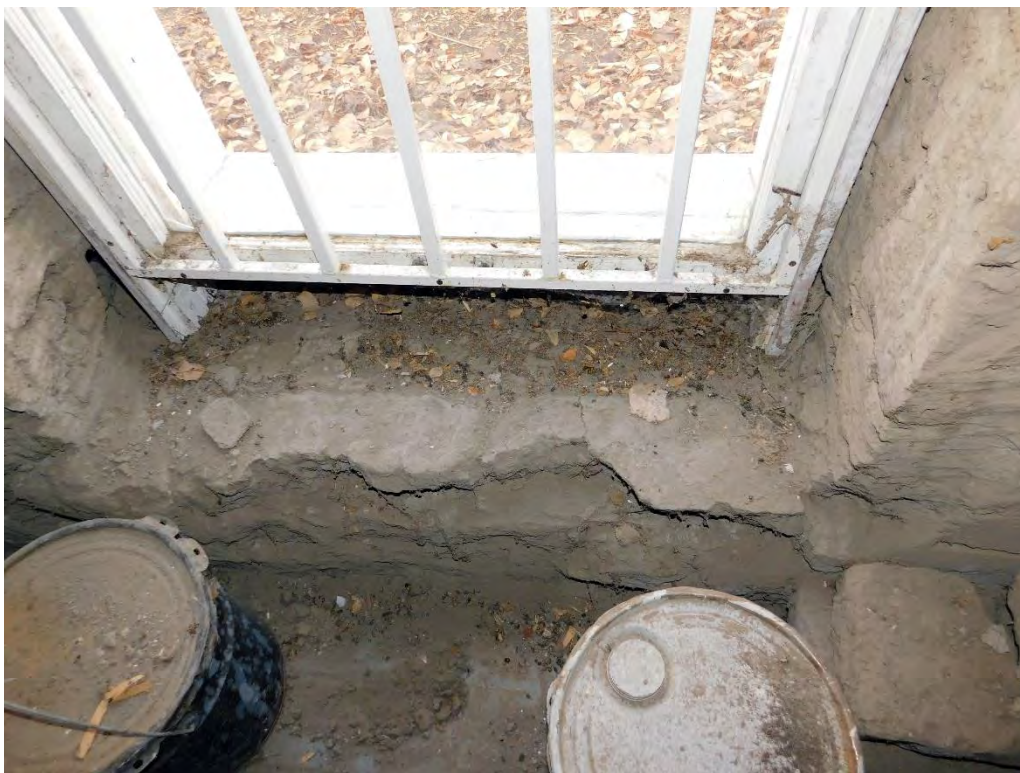
Window in the North wall; a contemporary metal security grille has been added. The adobe window sill exhibits damage.

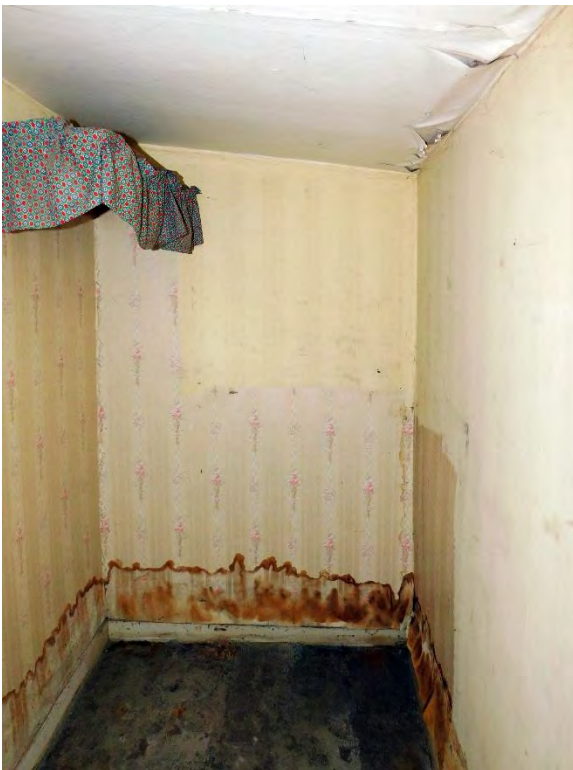
South end of Room 106. Damage from water is evident at the base of the wall.

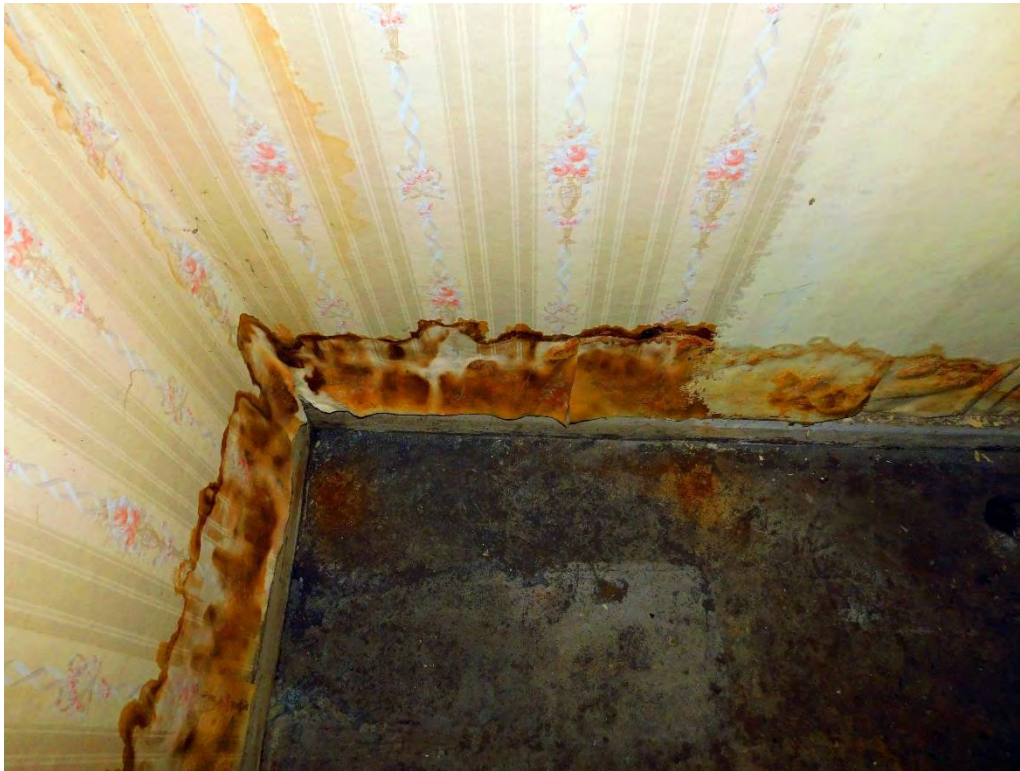
Close-up view of water damage. Note the wallpaper pattern.

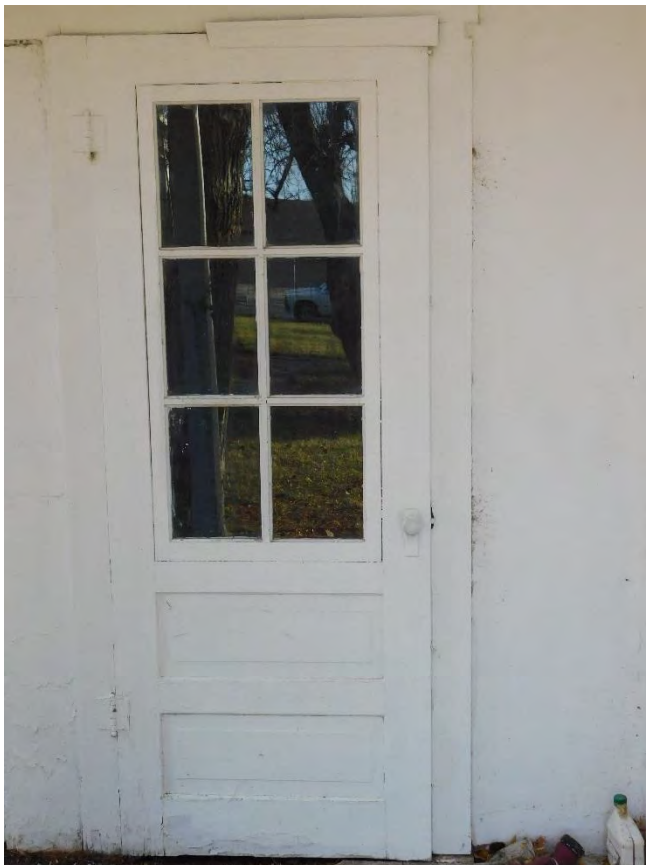
Closer view of the door above. Re-working of the casing / trim at the head of the door is recommended.
