HISTORIC STRUCTURE REPORT

I. G. BAKER RESIDENCE

1600 Block of Front Street
Fort Benton
Montana

BY
SIEVERT & SIEVERT CRC
MAY 30, 2019

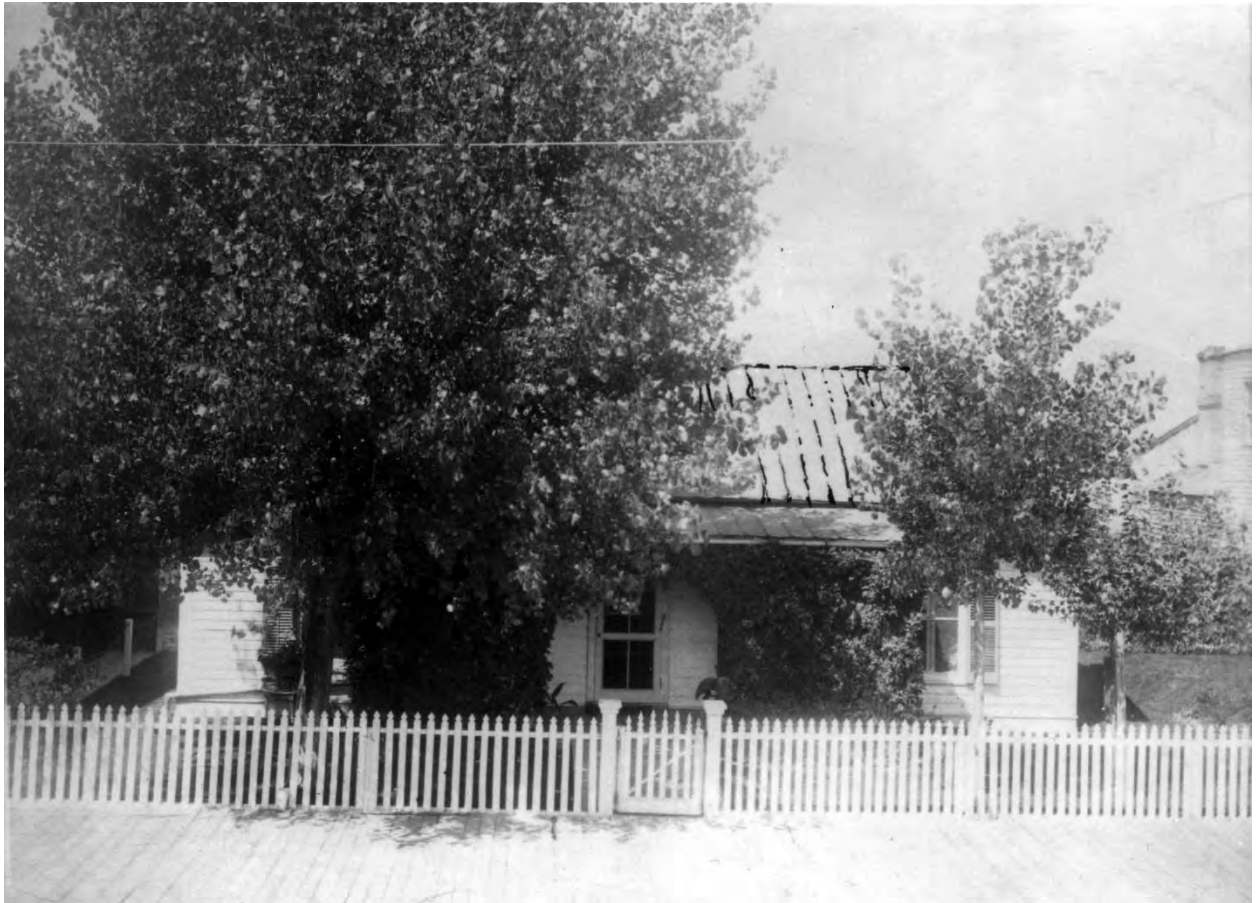
HISTORIC PHOTO

This photograph is identified as “Baker House Before 1908 – 600” in the files of the River & Plains Society archives. Note the metal roofing (confirming the information on the Sanborn maps) and the different style of fence across the front of the property. This photograph also shows shutters on either side of the front windows and a wood screen door over the main entry door. It appears that a hanging metal gutter extended across the porch edge only and that the downspout / leader carried water over to the corner of the house.

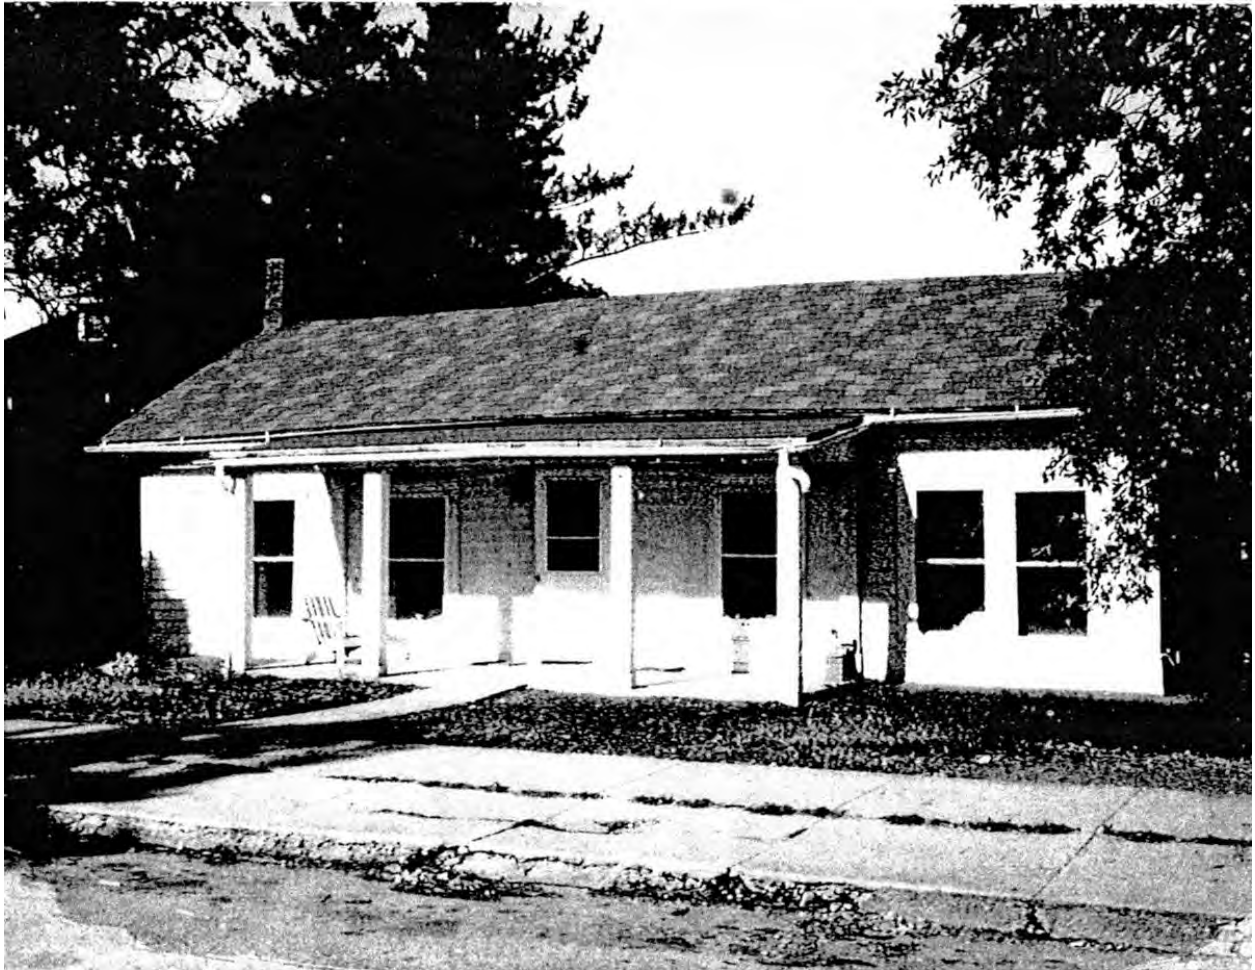
HISTORIC PHOTO

This photograph is attributed to a pre – 1950 date based on comparison with photos reproduced on the following pages. Half-round 'cavalry' style gutters are visible along the eaves; Half-round gutters were being produced in the latter part of the 19th century so it is possible that the I. G. Baker residence had hanging metal gutters during the period of significance.

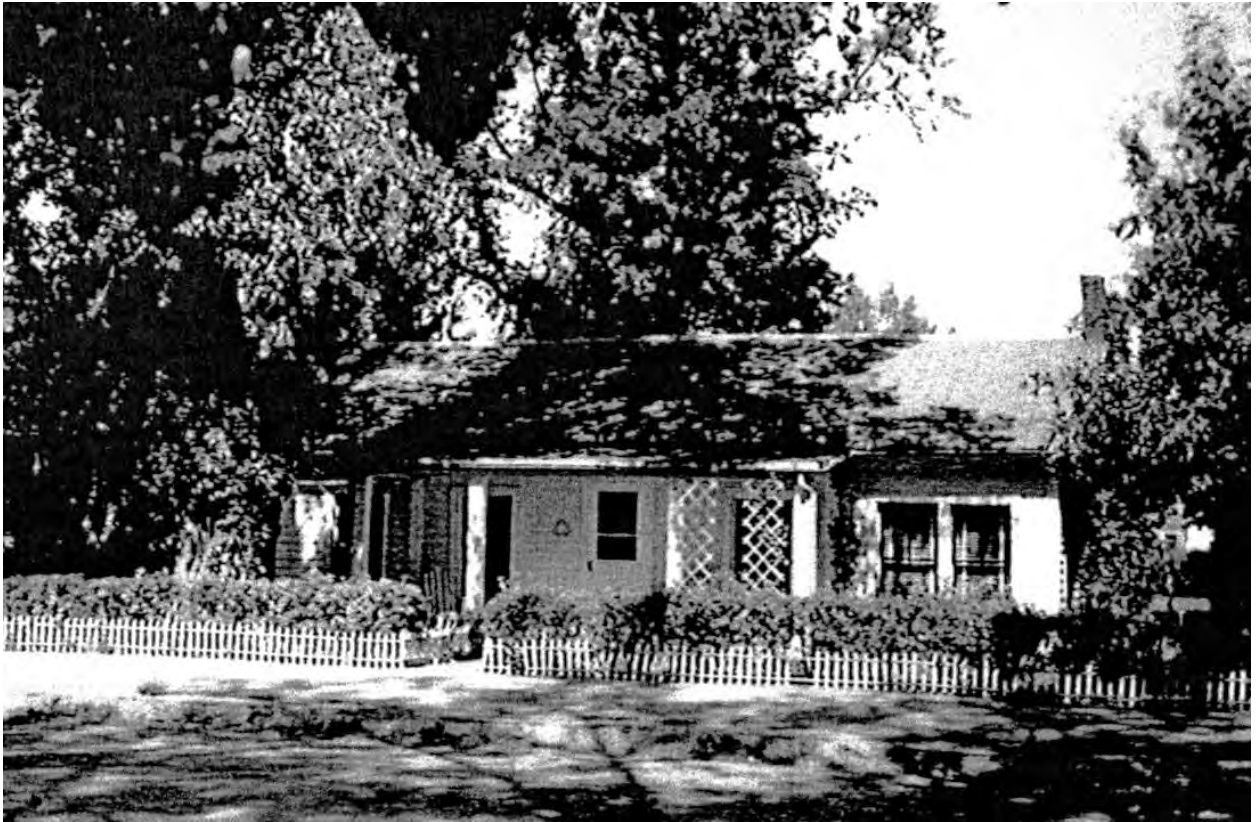
HISTORIC PHOTO

This photograph is believed to have been taken circa 1950 (note the similarity of the hedge height and the appearance of the decorative fence as compared to the photo on the following page). A chimney is visible on the extreme right side of the roof ridge that is no longer there; the chimney is attributed to a post 'period of significance' installation, and has since been removed.

The pair of windows on the North end of the wall were introduced after 1900 – they were replaced with a single window during the 1973 restoration to reconstruct the historic appearance of the residence.

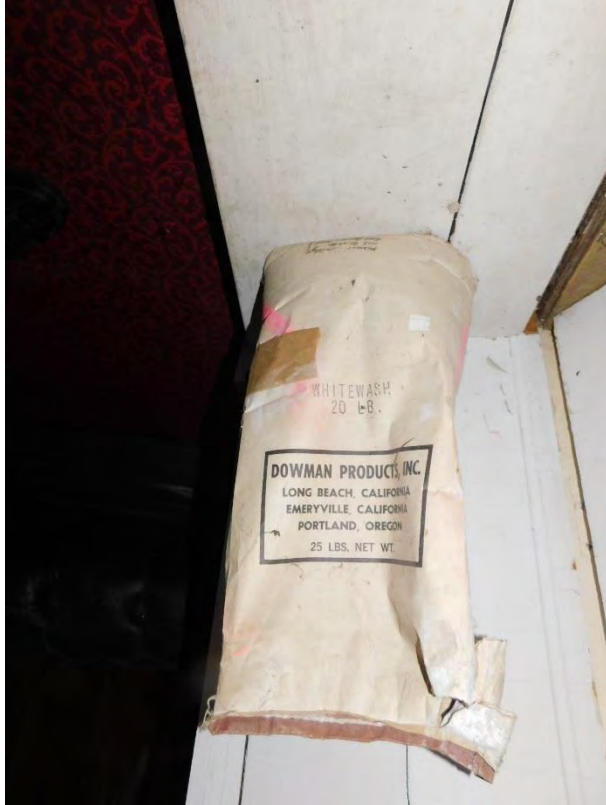
1. Pre-1970 plaster directly applied to the adobe walls. This application was utilized in rooms 102, 103, 106, and the east wall of 104. During the 1973-76 restoration it was removed in room 102 with the exception of the fireplace chimney; removed and replaced with a thicker application in room 103; and was removed in room 106 (although fragments remain). It continues to remain on a portion of the east wall of room 104. The exposed adobe in room 102 has been whitewashed as part of the current interpretive program for the house.

The photo at the left is of the whitewash material that was used for the 1973-76 interpretive program.

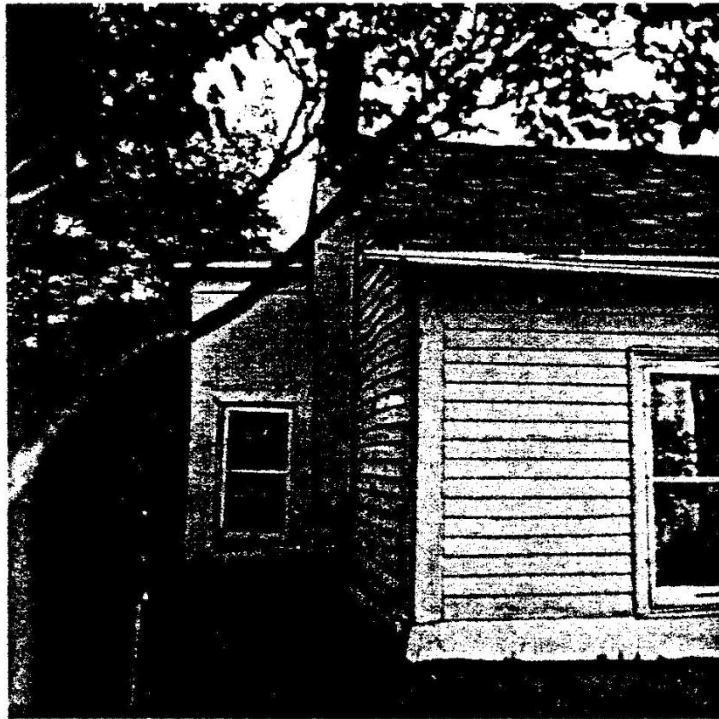
SW CORNER

Photograph extracted from Jack Lepley correspondence (1979).

Photographs attached to the Lepley correspondence show vertical wooden corner boards in lieu of the metal siding corners, and it is recommended that corner boards be applied to the residence.

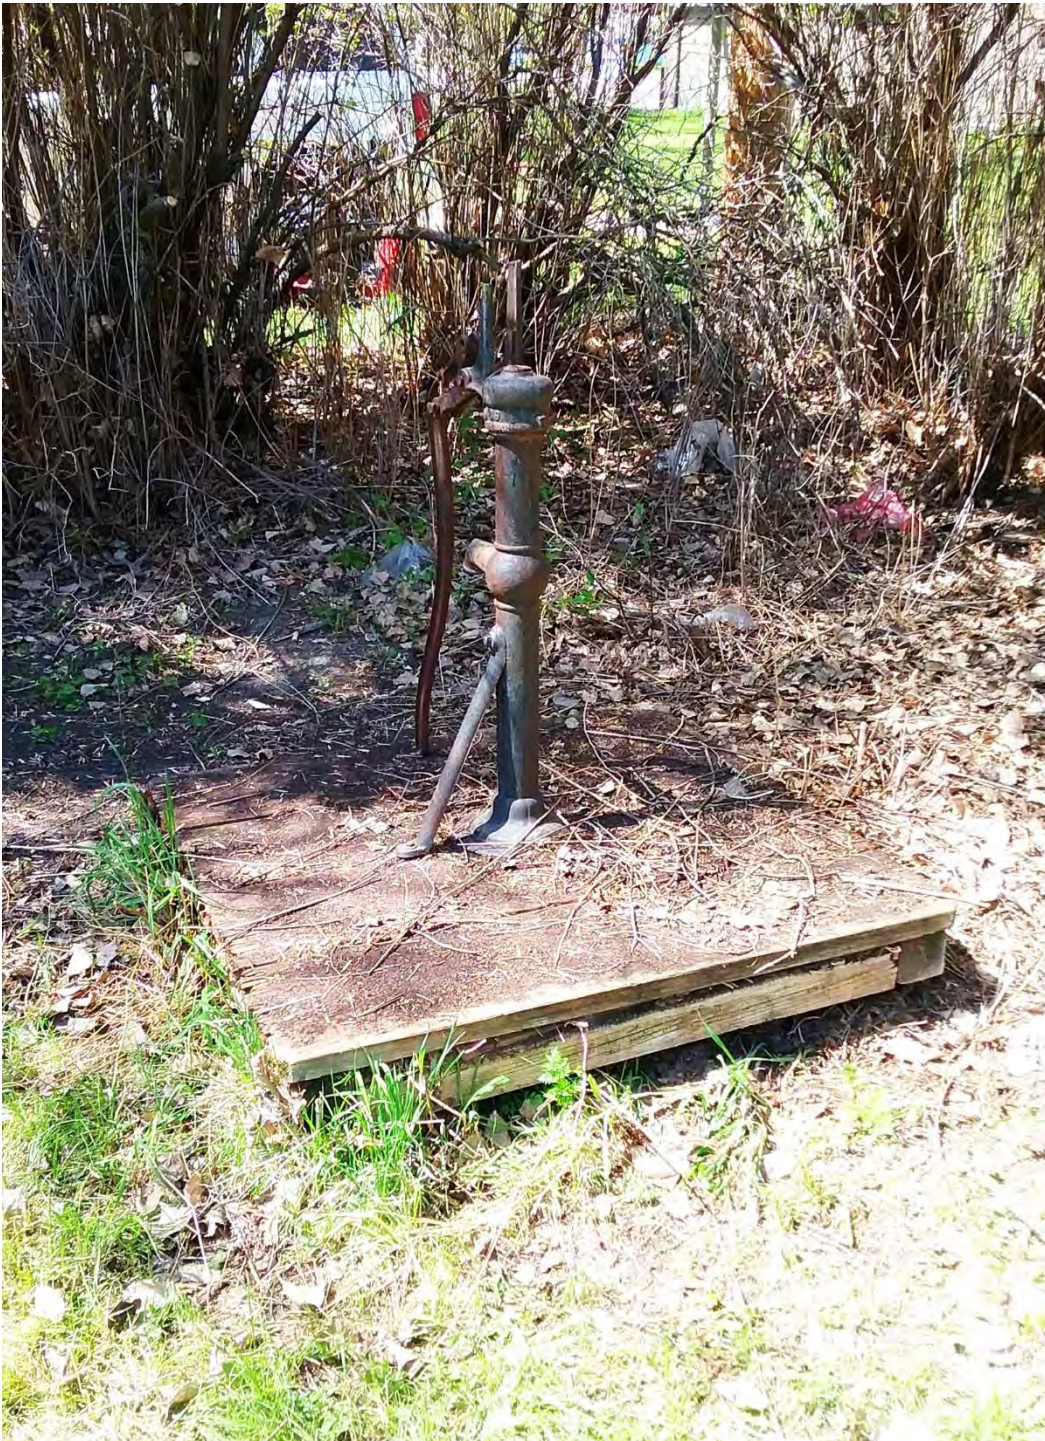
Photo of original well uncovered at the SW corner of the site during investigation of the I. G. Baker Residence.

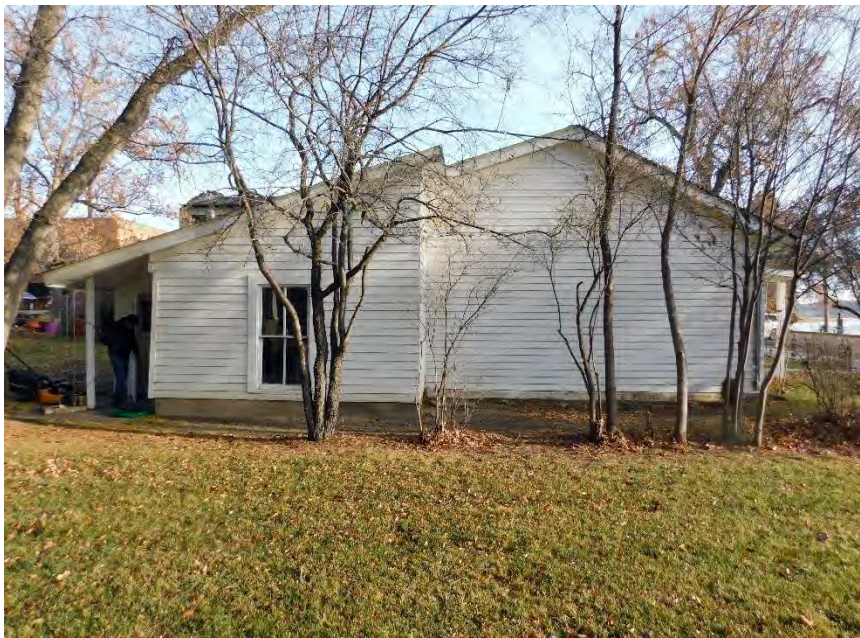
South Elevation. The window visible on this wall has been relocated; it originally was in the offset wall facing Front Street. Note that the chimney on this end wall has also been removed.

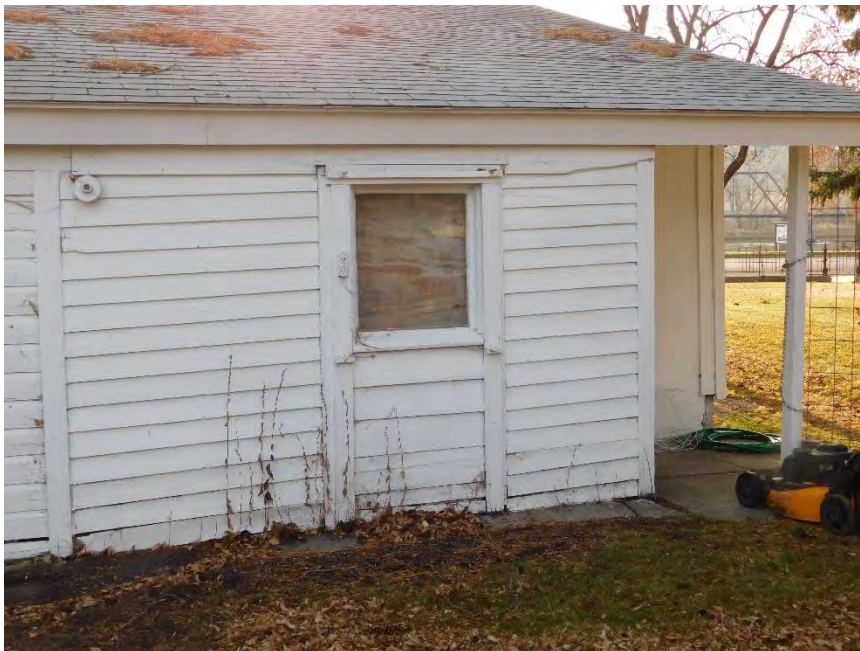
Southwest corner of the West Elevation. Note the use of corner boards, the different types of siding, and the splice location in the wall visible on the left side of the photo.

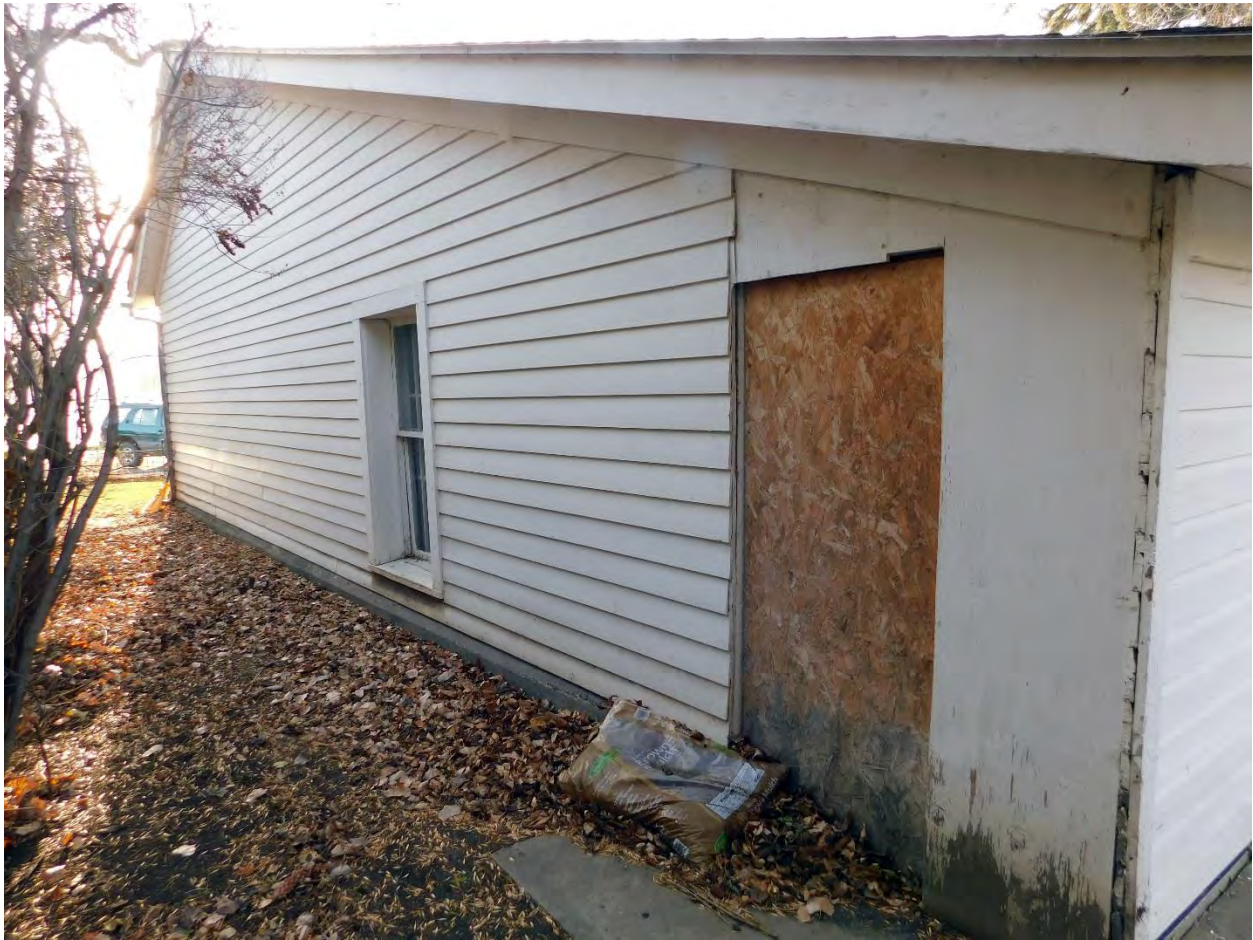
North Elevation of the residence. The concrete foundation / weather wall that was constructed in 1973-1976 is visible along the bottom of the wall in this photograph; note that it ends at the edge of the door opening (behind the bag). Painted plywood has been used for the wall surfacing at the West end of the wall, and the unfinished particle board denotes the door opening at this corner of the residence.

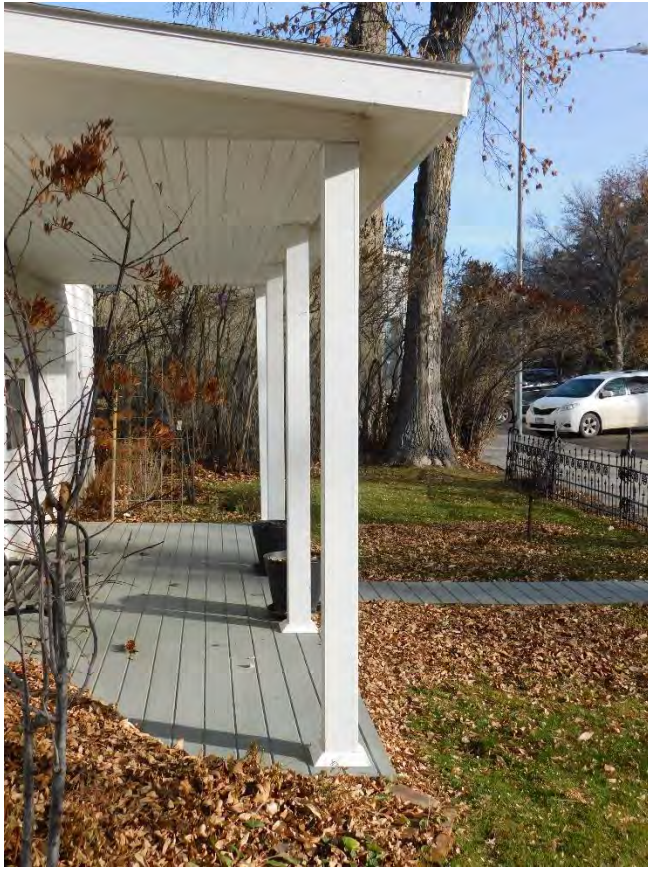
View of the porch that is centered on the main elevation facing Front Street. The porch was rebuilt during the 1973 – 1976 restoration, based on the 1973 restoration drawings. The reconstruction was specified to match existing profiles and the overall scale, configuration, and placement is consistent with historic photographs.

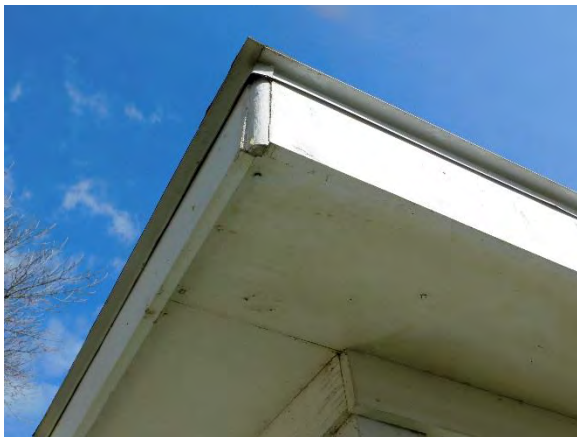
SE corner of the Porch roof. The plywood soffit is painted; and a quarter-round has been installed at the corner of the fascia.

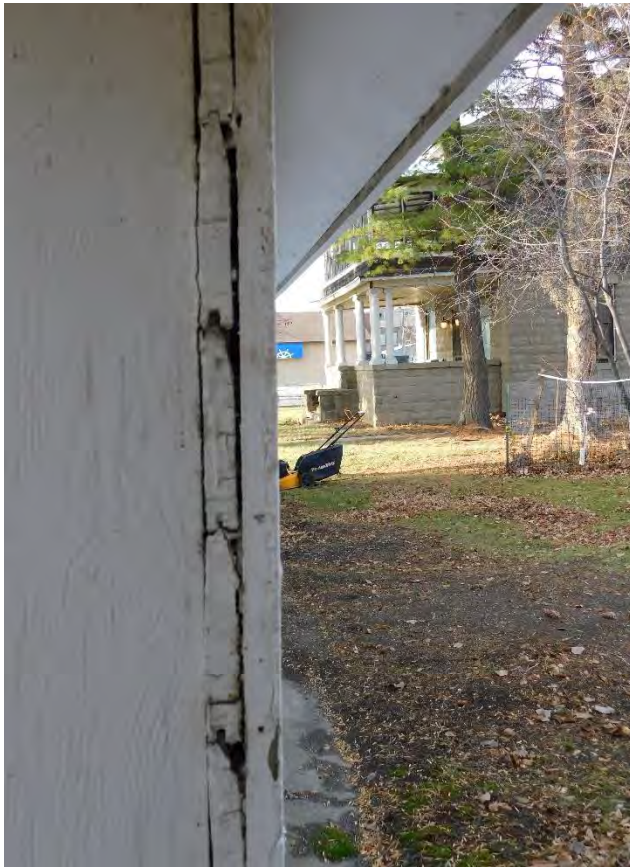
NW corner of the house; the photo illustrates how the T & G drop siding is installed and shows a typical 1x corner board to trim out the end of the wall.

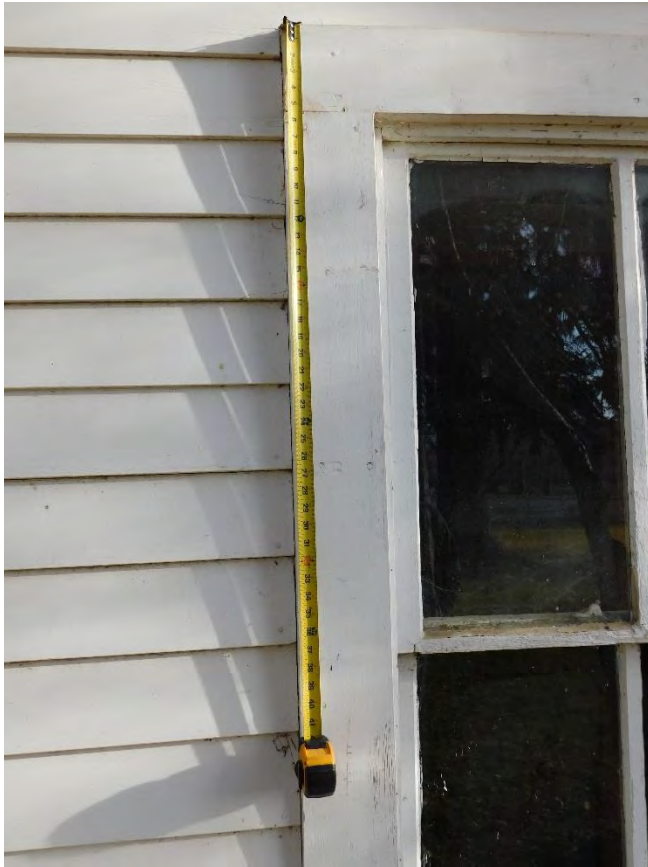
Typical detailing of the current siding and current casing / trim details at openings. Original siding may have been drop siding rather than beveled (based on the West elevation); however, the pattern could not be verified during this study. The flat casing and size is appropriate to the period of significance.

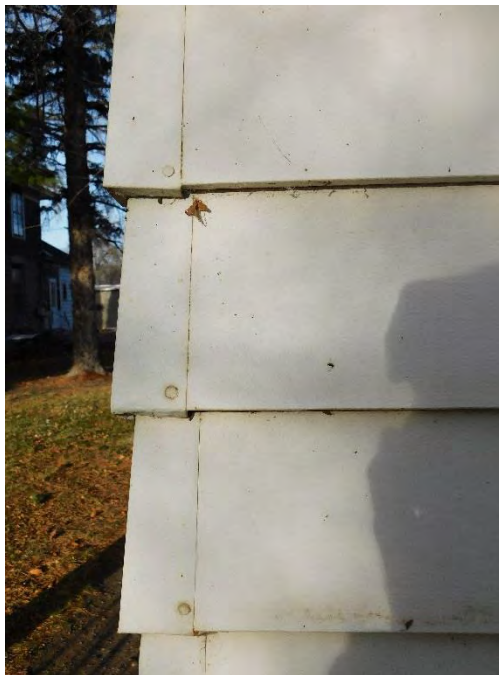
The metal corners are attributed as not being original to the house (bending of sheet metal, other than hand forged, was not common until the late 19th century). Historic treatment of the exterior corners of the house would likely have used corner boards, or possibly alternating lapped butt joints if the siding material was of sufficient thickness.

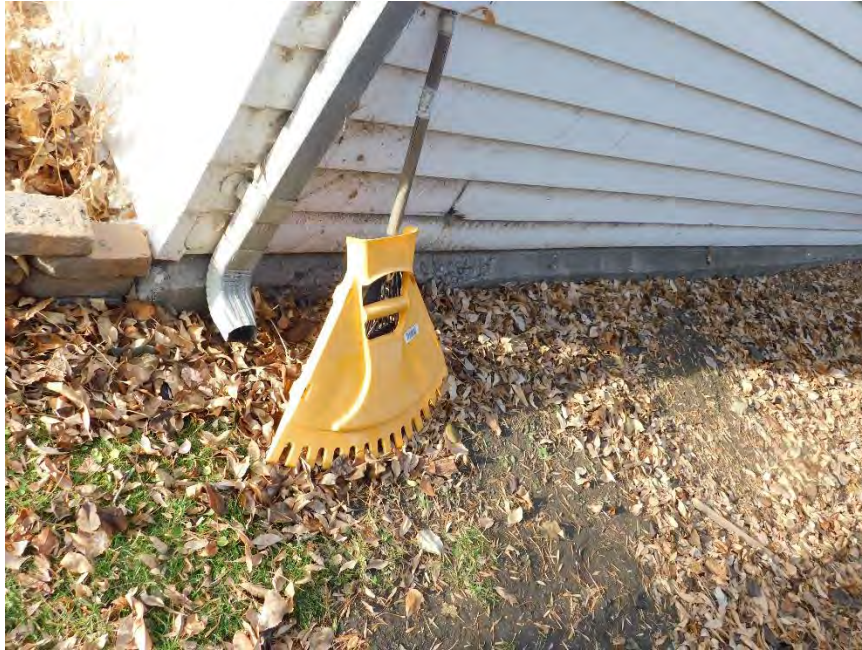
The top of the protective concrete weather wall (circa 1973-76) can be seen at the NE corner of the residence. Note the watershed profile at the top of the offset weather wall.

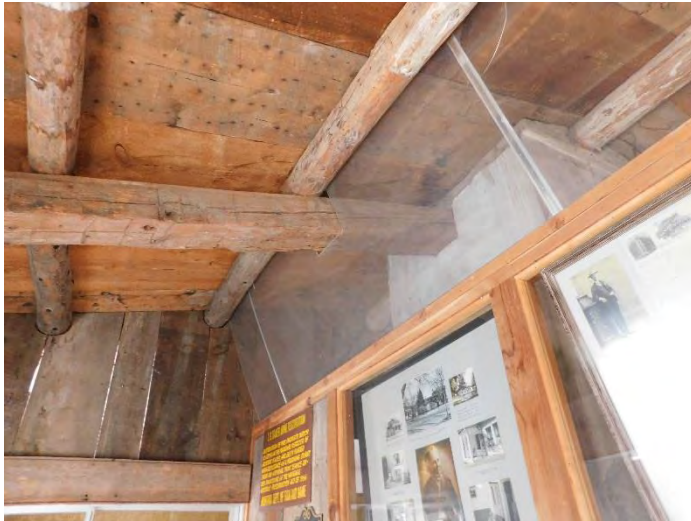
Ceiling detail showing the intersection of the 1970's plexiglass enclosure with the historic ceiling materials.

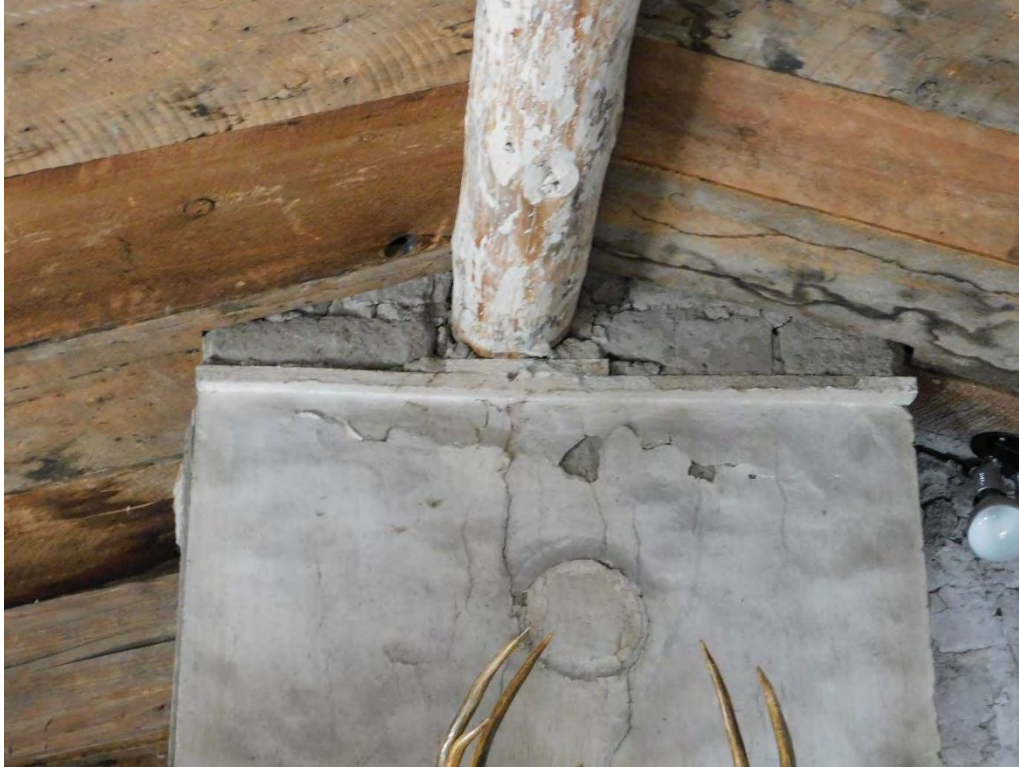
Top of fireplace chimney; note parging over adobe.

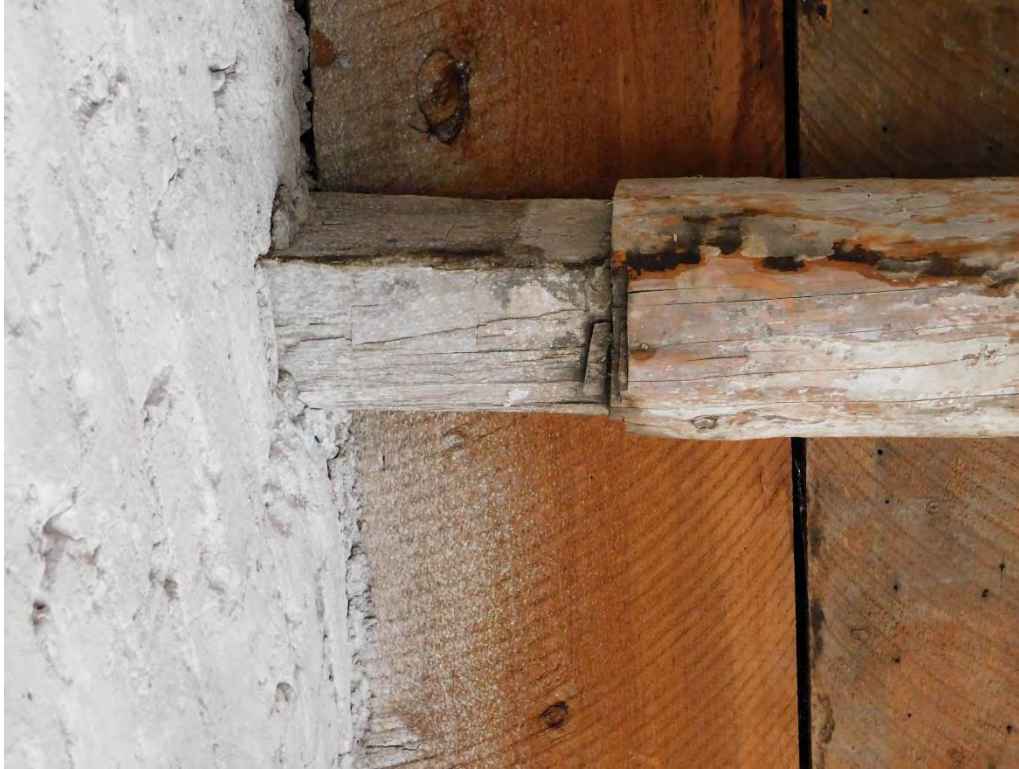
Detail of end of log purlin; note some of these purlins were re-set in the 1970's (see text)

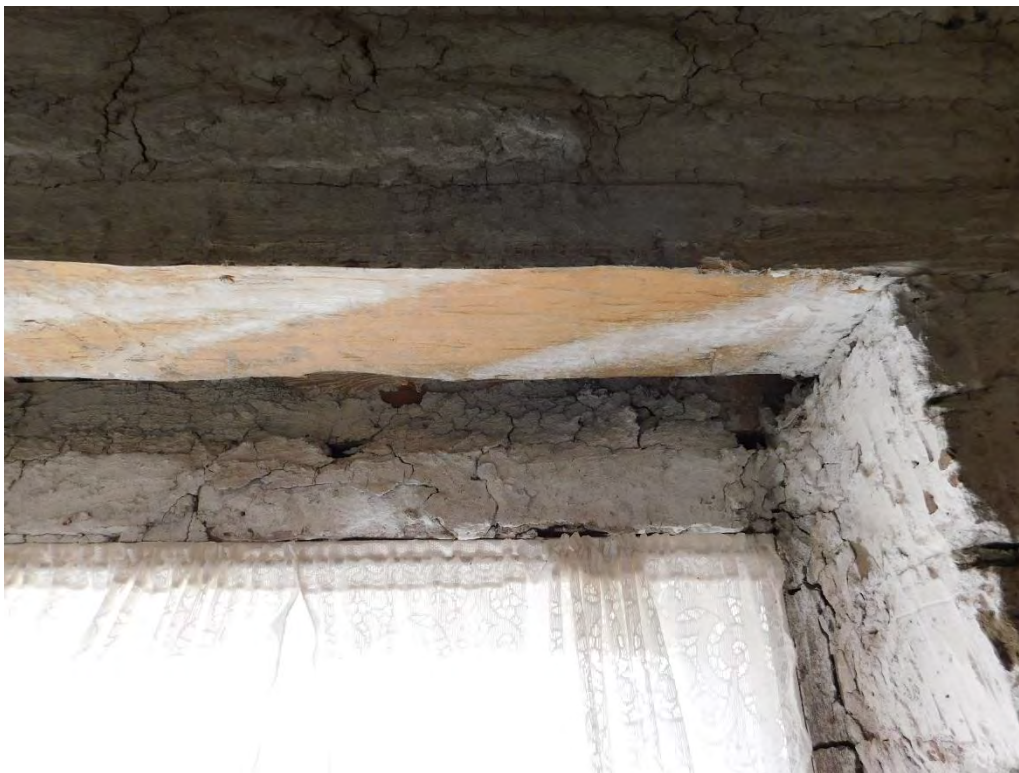
Window detail; note wooden lintel that supports the adobe wall.

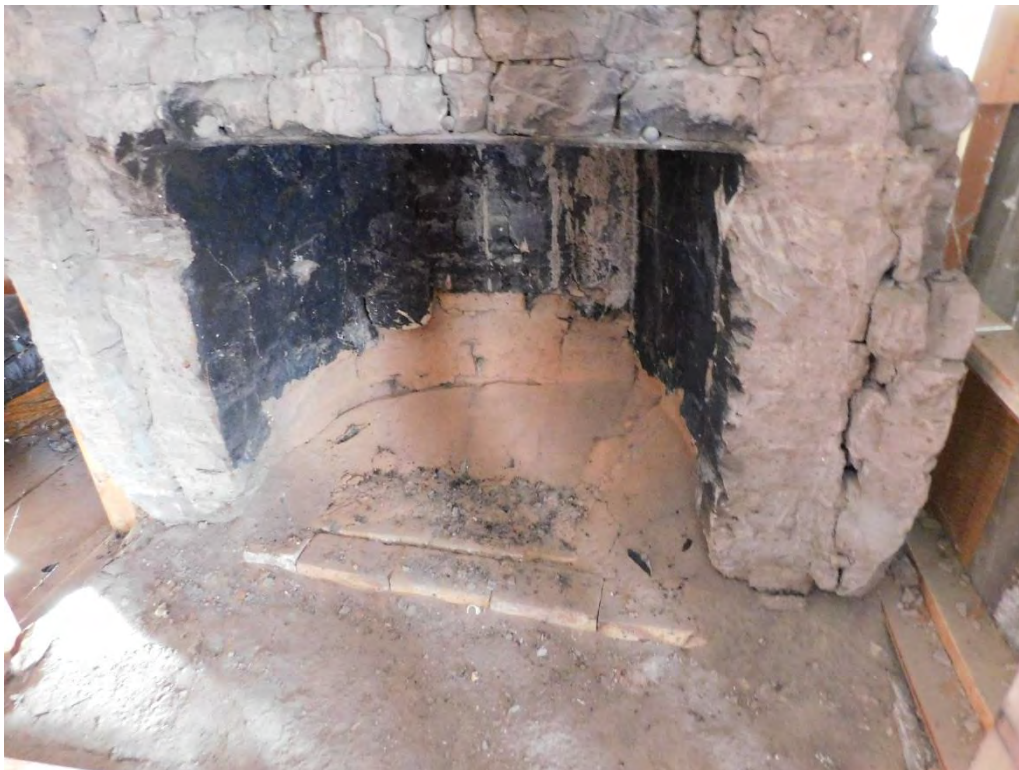
Fireplace in Room 103. The adobe construction, parging, and char and residue from smoke is still visible.

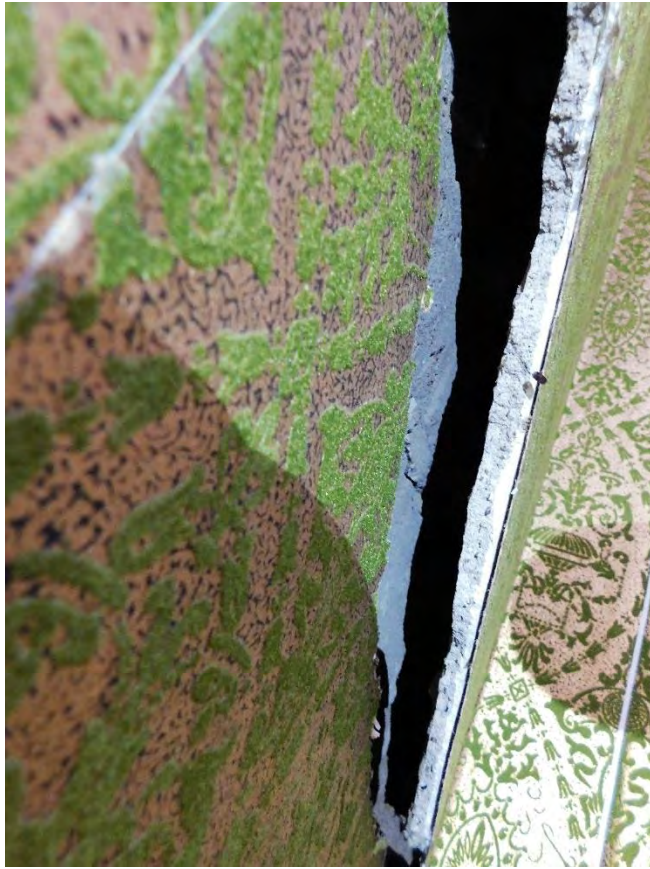
View showing the wall construction in Parlor 103. A coat of smoothing plaster was applied over the adobe substrate before installing wallpaper during the circa 1876 renovations. During the 1973 – 76 restoration, original wall paper was removed (or missing) and a hard coat finishing plaster was applied to the surface (shown by the narrow white material in the cross section). The final step was to apply new wallpaper over the wall.

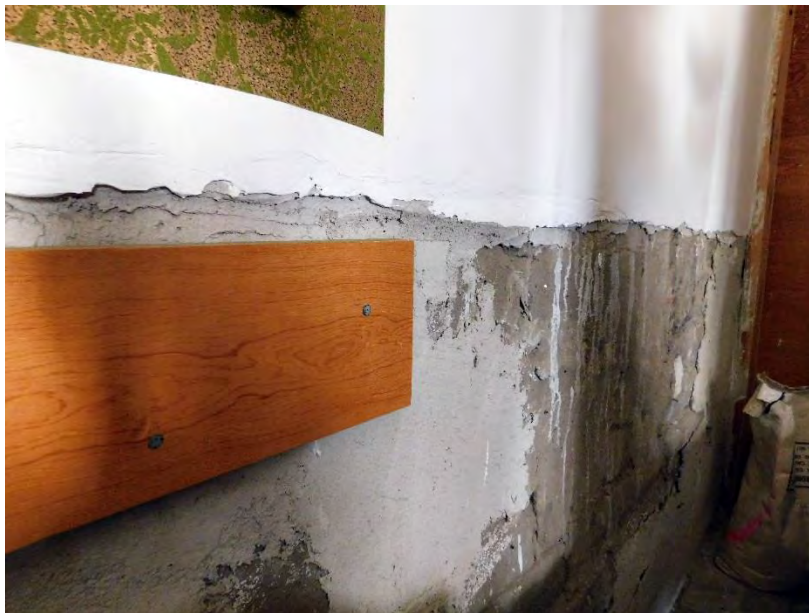
The description of construction above is also visible where the wainscot was not completed along the North wall of the space.

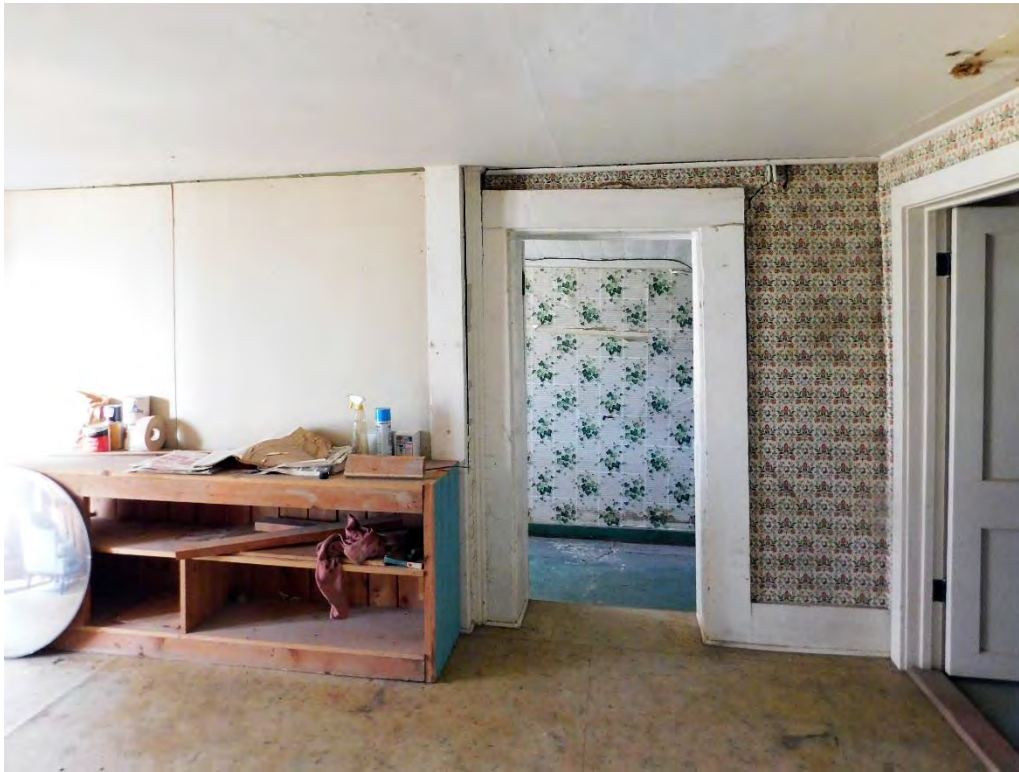
View of West wall;
note variety of
materials.

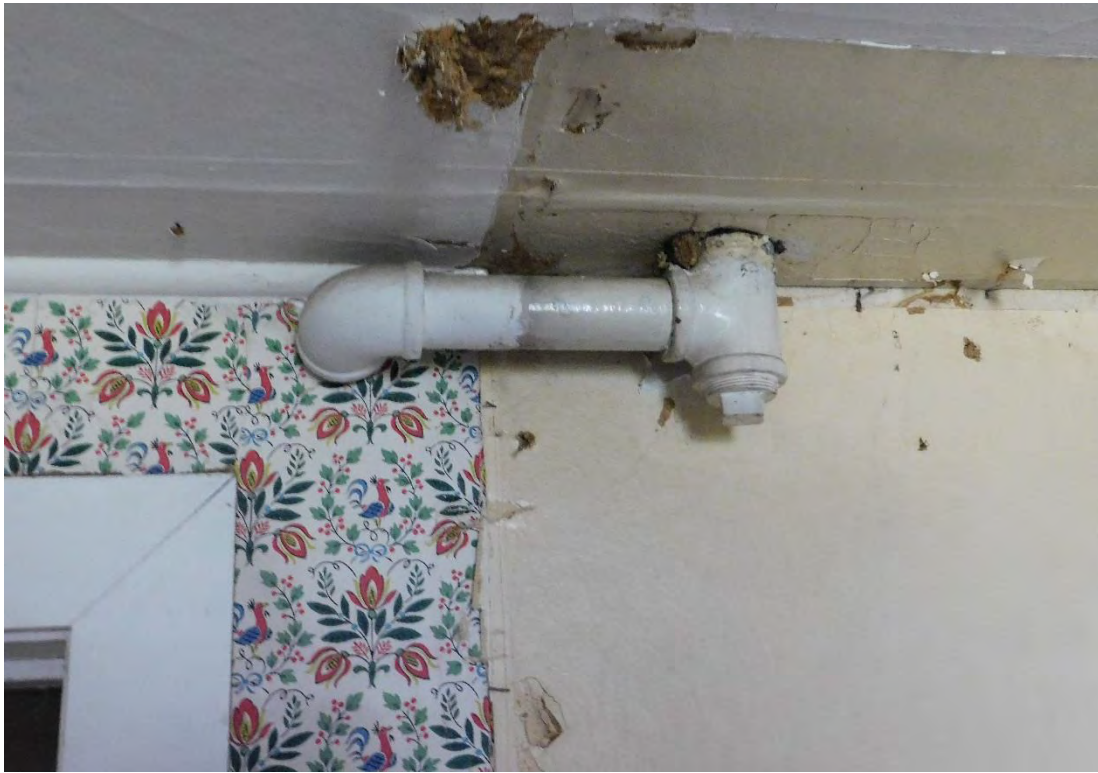
Intrusion from plumbing at ceiling along North wall of room.

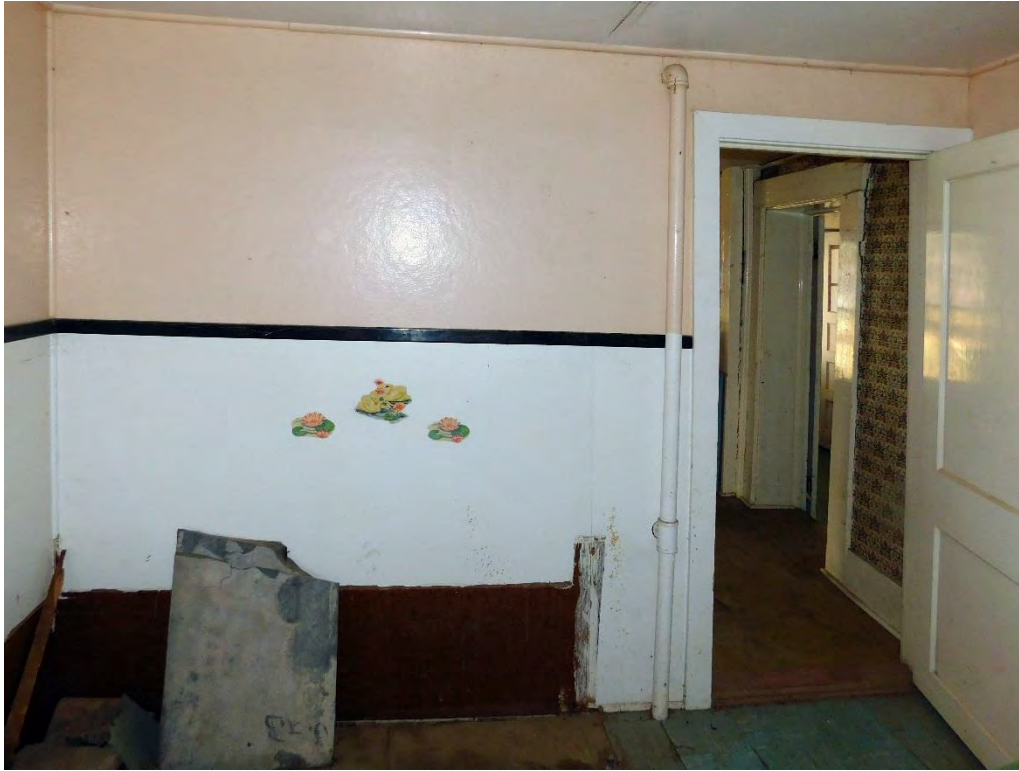
View of South Wall;
all wall surfaces in
this room are
contemporary
materials.

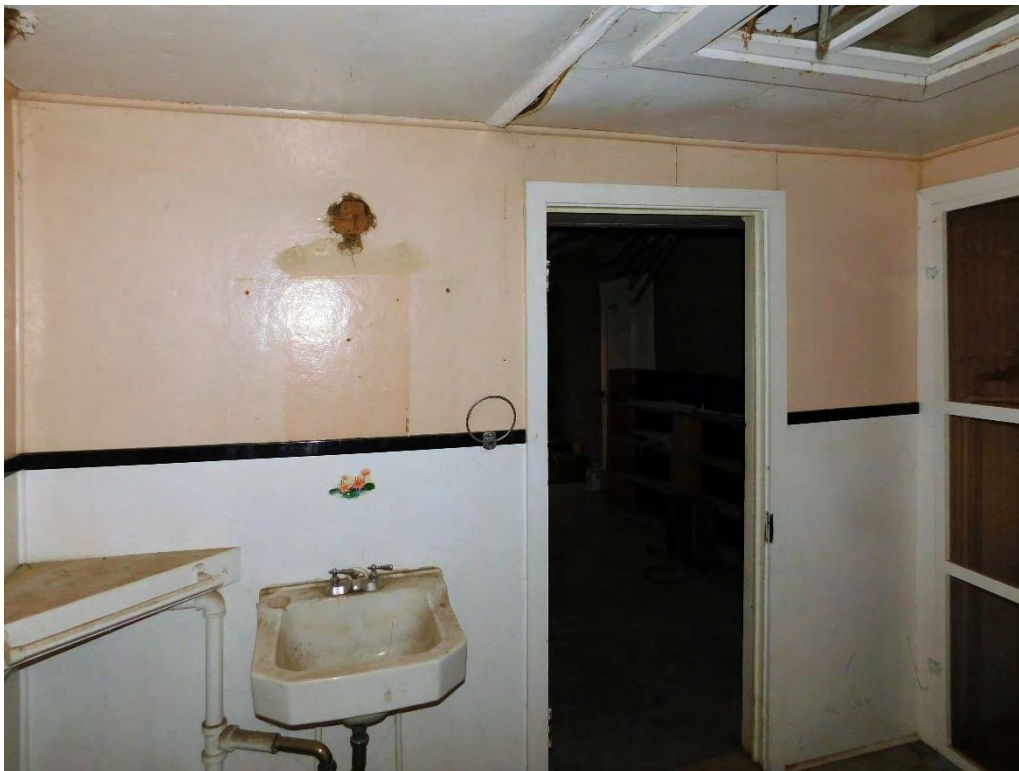
View of North wall;
the door at the
extreme right in the
photograph
accesses a closet
for the water heater
(recent installation).

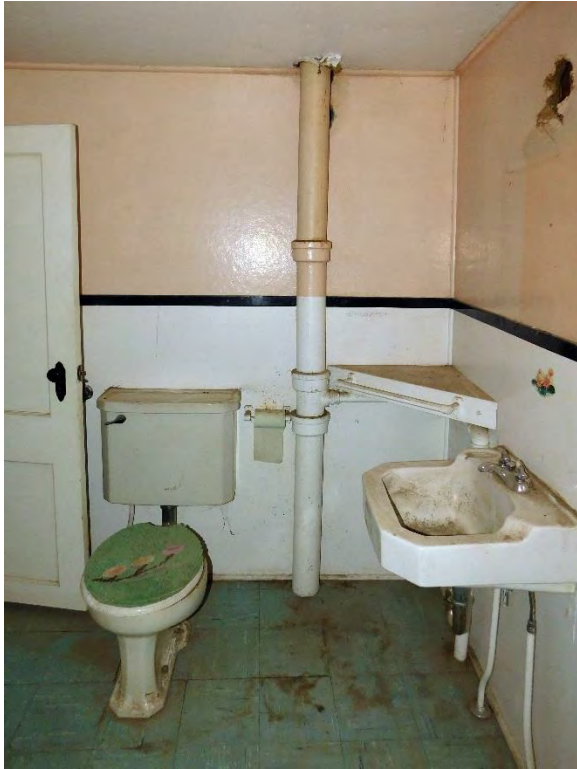
View of West Wall; flooring material is 8 x 8 tile that has been introduced into the historic residence in recent times.

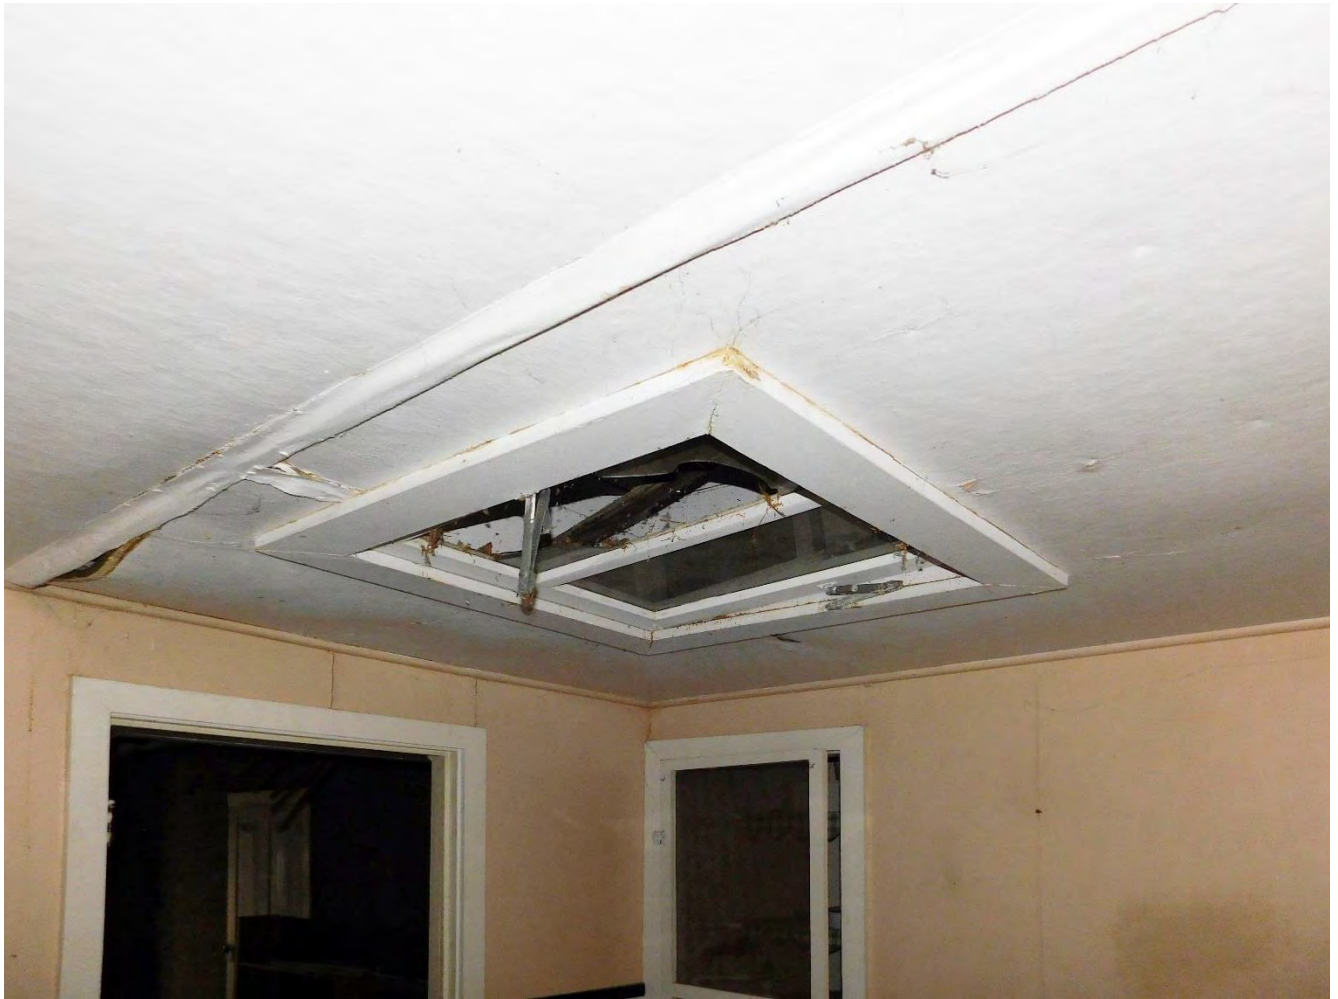
Access panel in ceiling (see plan for location). It is unclear as to how this was intended to function since the interstitial space above is open to the adjacent Room 106 on the North end. Note that the ceiling appears to be painted mineral fiber board (Celotex).

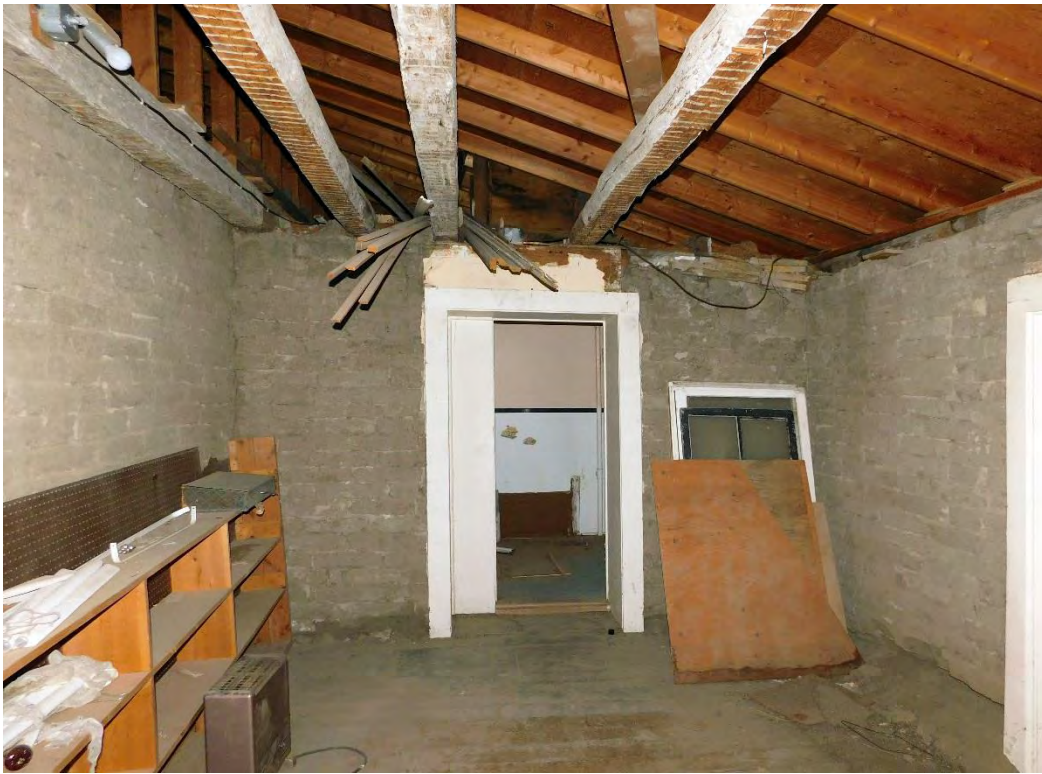
View of South Wall looking toward Bath; note that all walls are original exposed adobe, some log purlins from the historic ceiling remain, and that the door in the center of the wall has been altered from the original width
