HISTORIC STRUCTURE REPORT

I. G. BAKER RESIDENCE

1600 Block of Front Street
Fort Benton
Montana

BY
SIEVERT & SIEVERT CRC
MAY 30, 2019

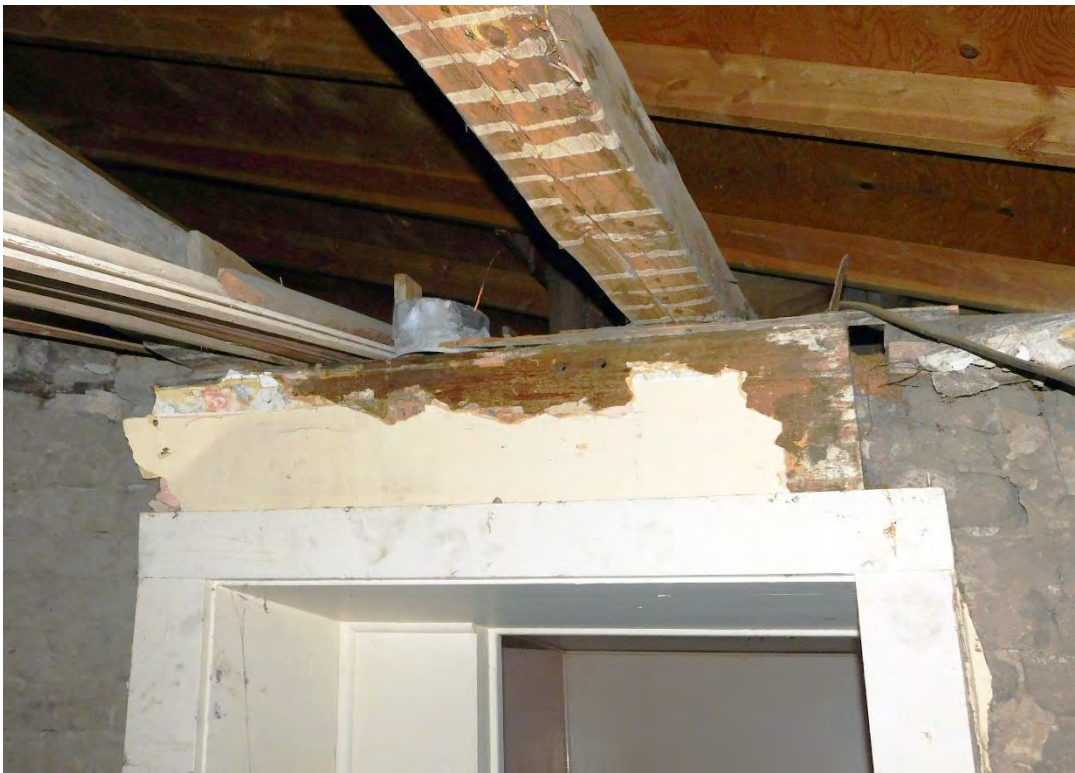
Detail at top of door in South wall – the wall exhibits remnants of different finishing materials (including wallpaper) and the wood infill used to narrow the door can be seen. View of East wall.

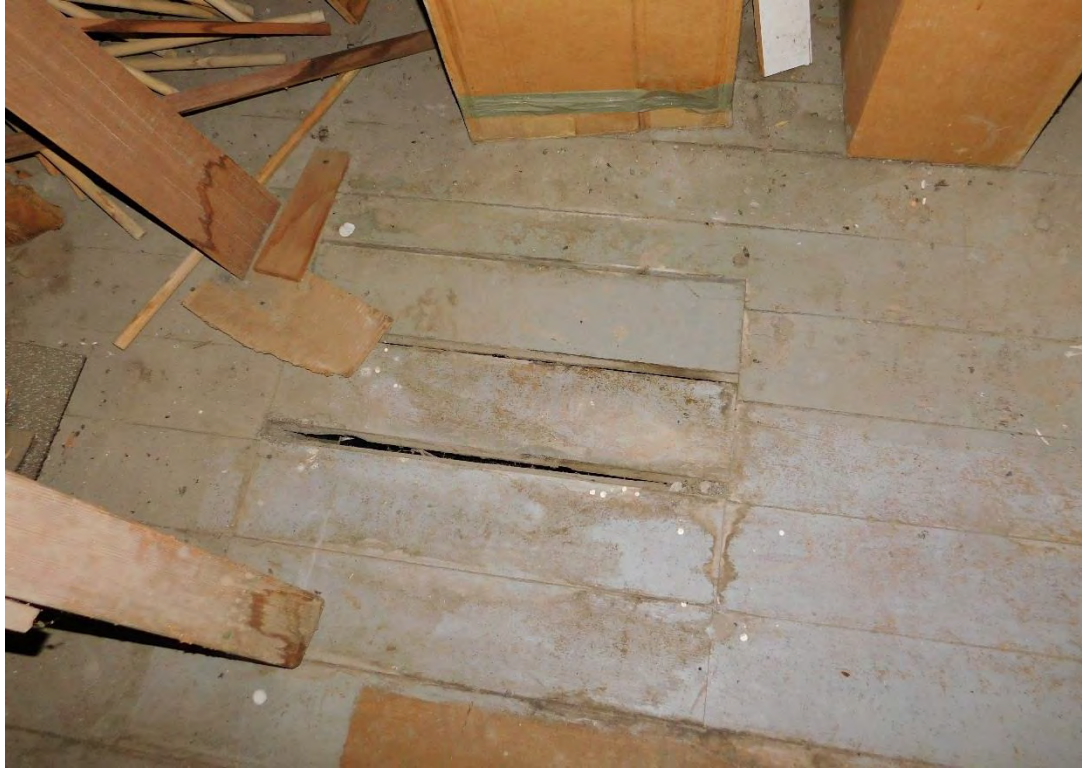
Access panel in
the floor of
Room 106.

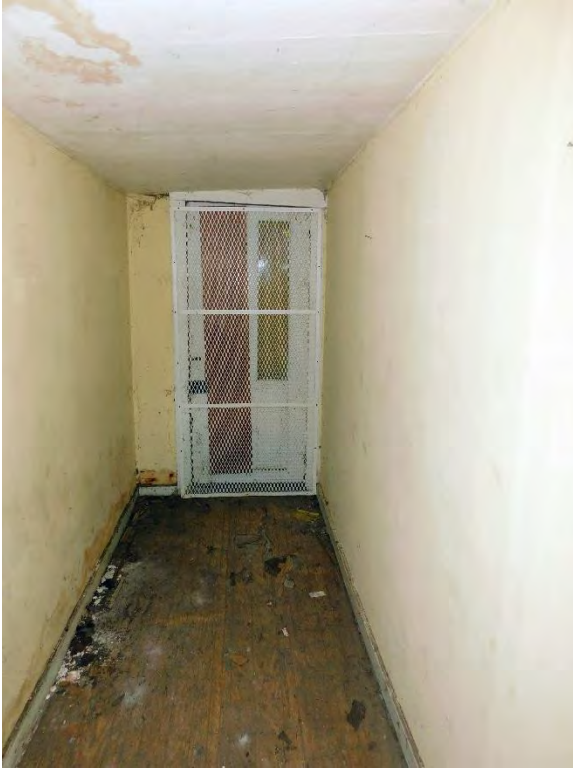
View of North end of space; note security barrier over door opening (contemporary).

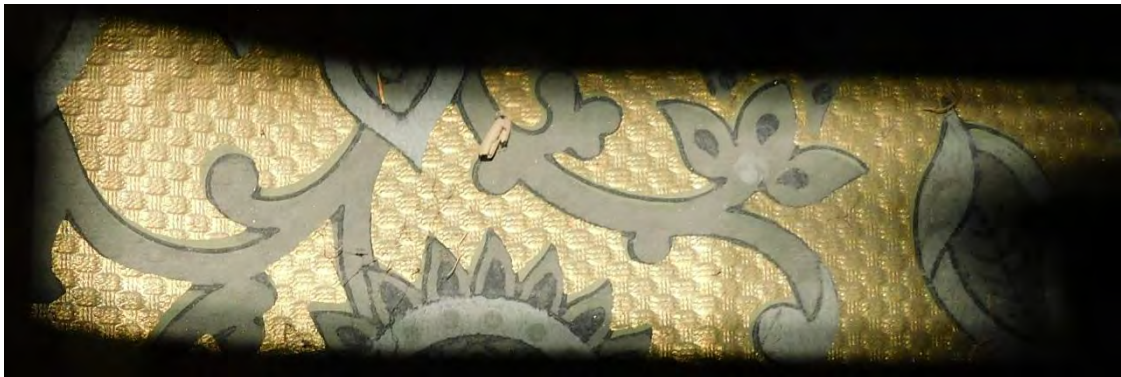
West wall of Kitchen / Utility 104. This wall was concealed by a newer furred wall and the wallpaper was found underneath. This is believed to be an 1876 wallpaper pattern.

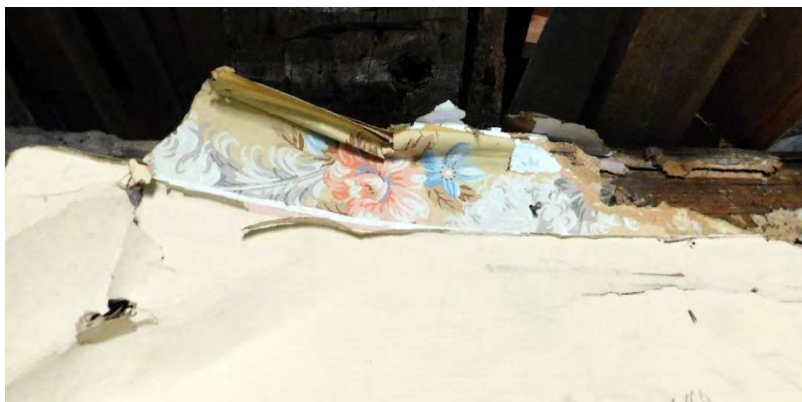
Remnant of border at top of south wall in room 106 (Private Quarters). The date of this wallpaper pattern is unknown.

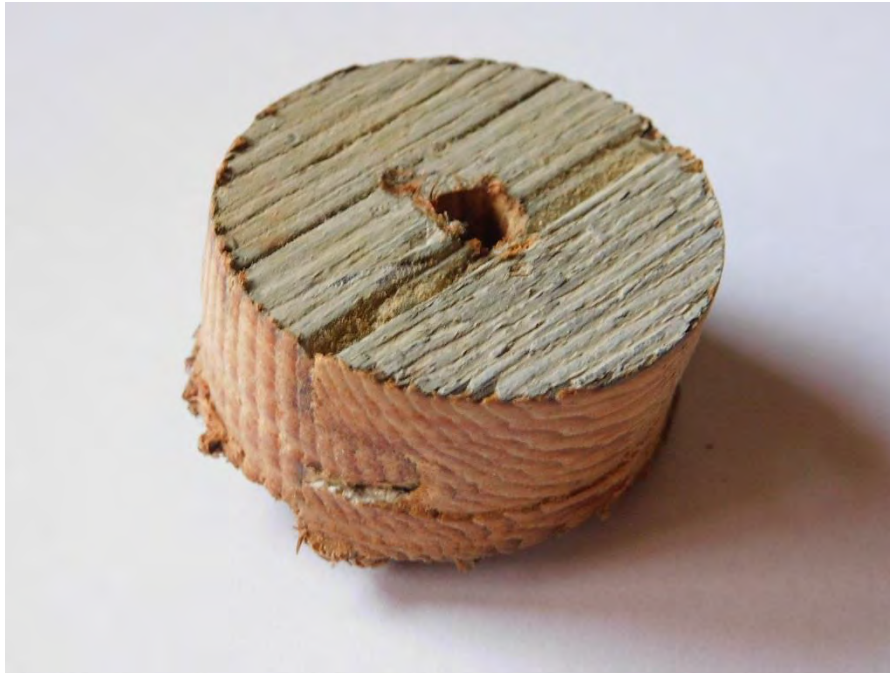
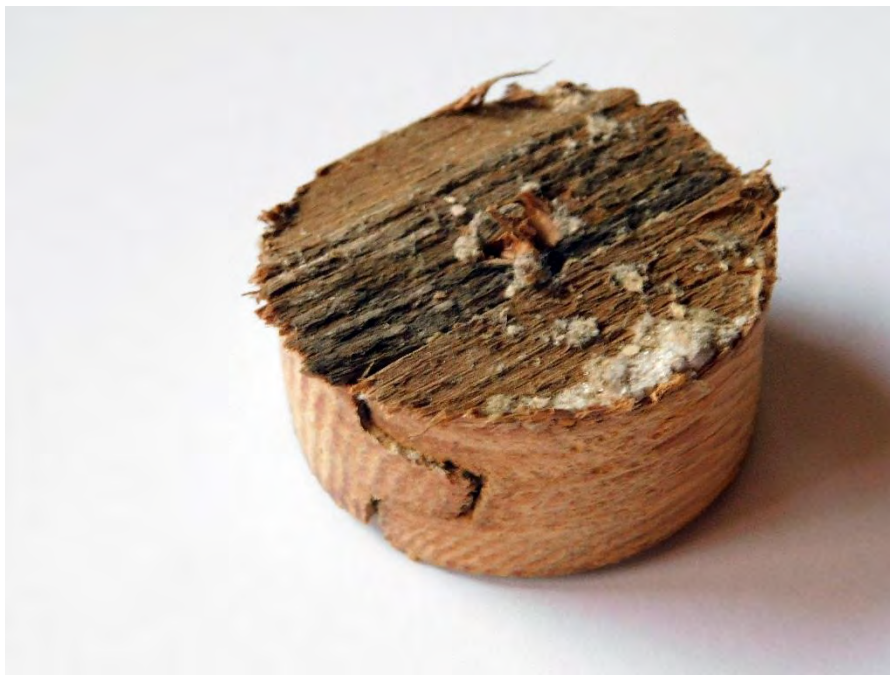
Core taken from the lower west wall of room 107. Starting from the interior – there was a layer of wallpaper, then a layer of Celotex, and then the T & G wood sheathing shown in these photos. Remnants of the Celotex are visible on the surface of the lower photo.

This material was either exposed to the weather (implying an open alleyway) or it was salvaged material as both sides of the wood show weathering and the upper photo shows a painted surface.

A cavity exists between this sheathing and the outside wall which is believed to be a wood framed wall; it has been filled with cellulose insulation (which was wet at the time of the investigation).

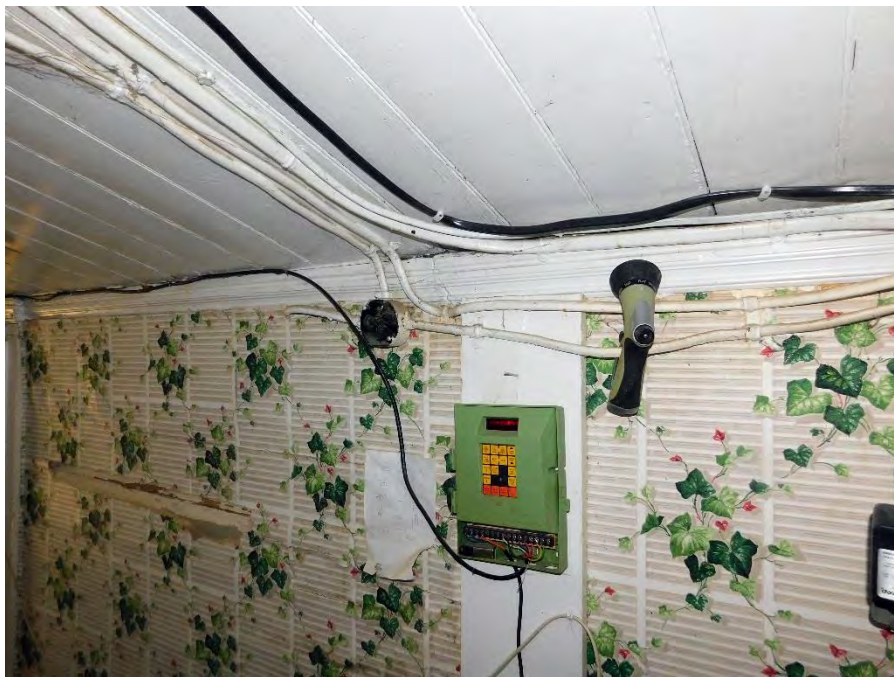
Irrigation controller located on the West wall of the rear vestibule. Note the various generations of exposed wiring.

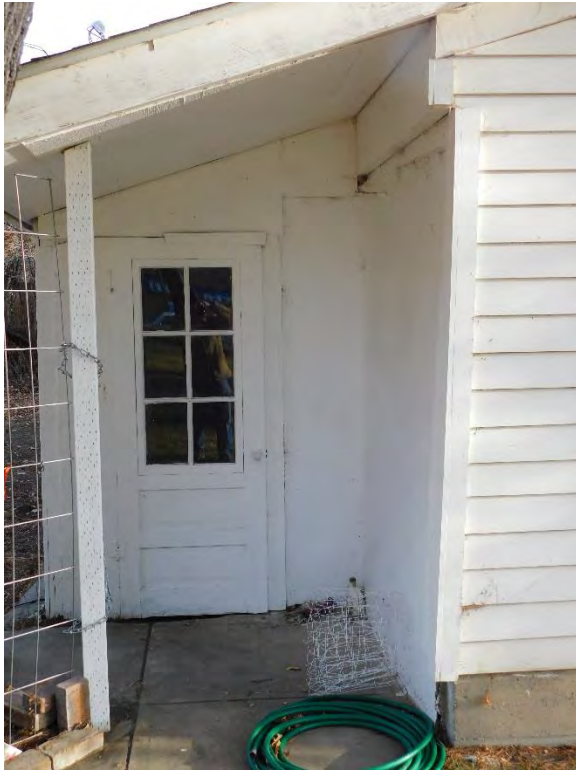
Door accessing the rear vestibule at the SW corner of the residence. Provenance of this door is not known; however, it is compatible with the period of significance and there is no reason to remove it.

Closer view of the door above. Re-working of the casing / trim at the head of the door is recommended.

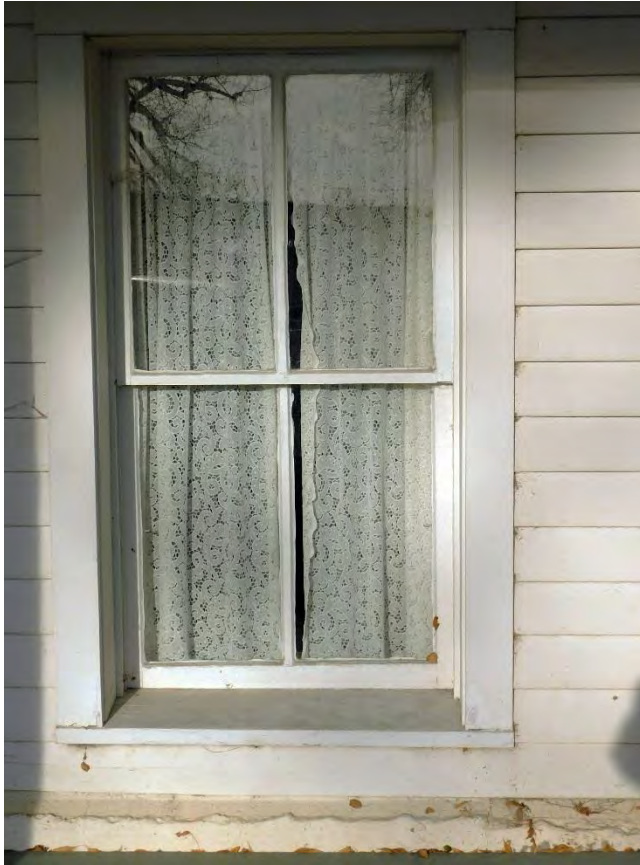
Typical window treatment at the residence. Note the deep recess of the window resulting from the extraordinary thickness of the exterior walls. This recess is important to the historic character of the residence.

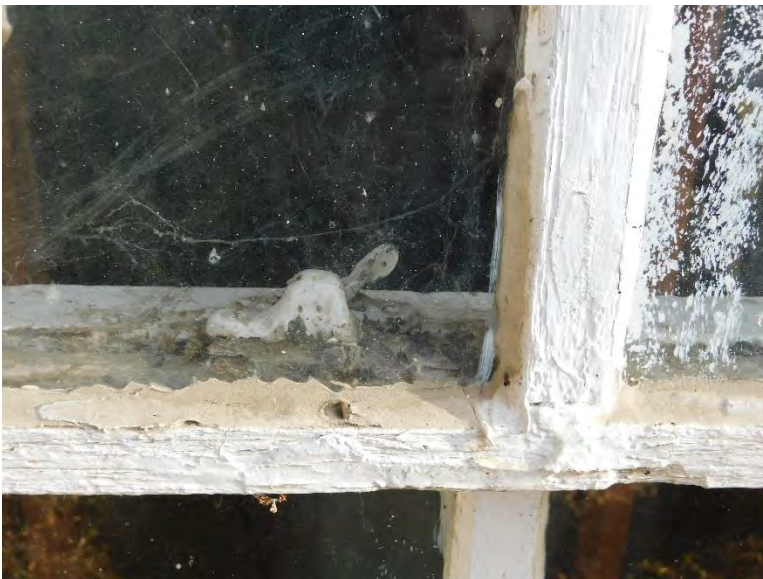
Detail of the historic sash lock typical used on the South facing window of the Kitchen / Utility area. This photo also illustrates the need for maintenance / prepping / painting at the historic landmark structure.

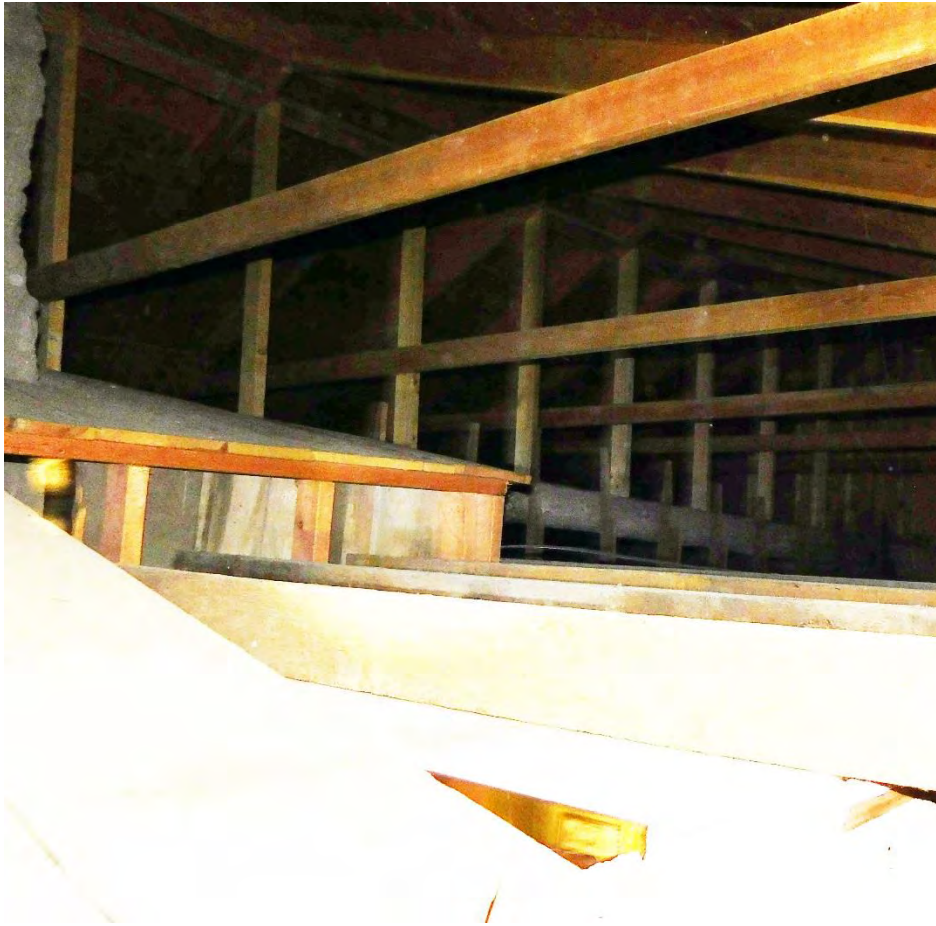
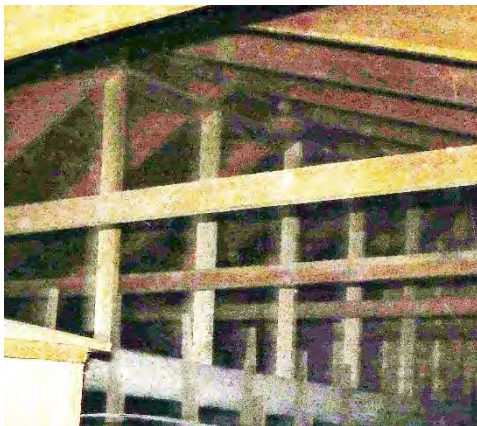
Roof structure above South end of original building; the original log roof purlin remains – all other parts of the original roof have been removed. Note that the newer roof is transferring load onto the log, the suspended ceiling above parlor 103 is hung from the log, and that the log exhibits deflection.

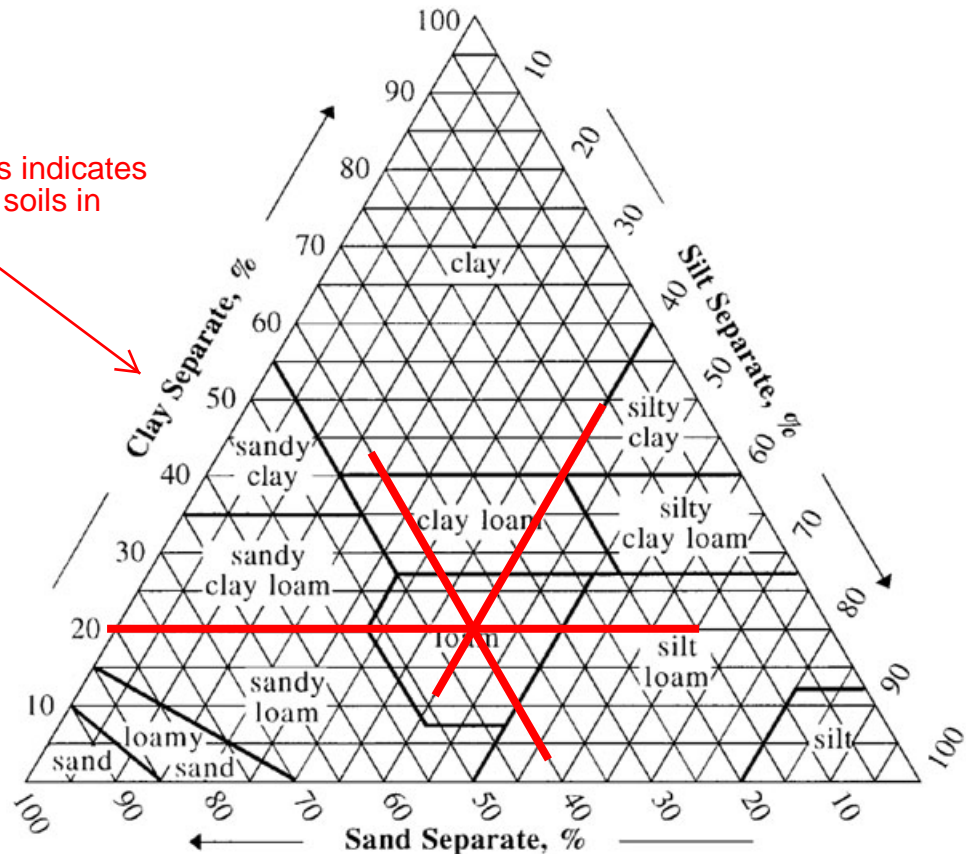
Intersection of Red lines indicates
approximate mixture of soils in
the adobe bricks at the
I. G. Baker Residence

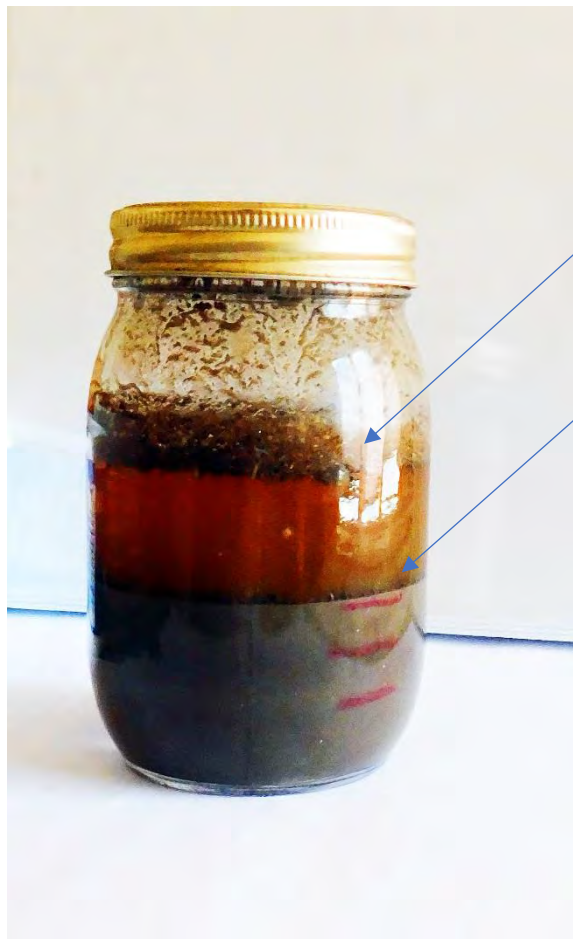
Results from a “Jar Test” of materials taken from an adobe brick retrieved from the site of the I. G. Baker Residence.

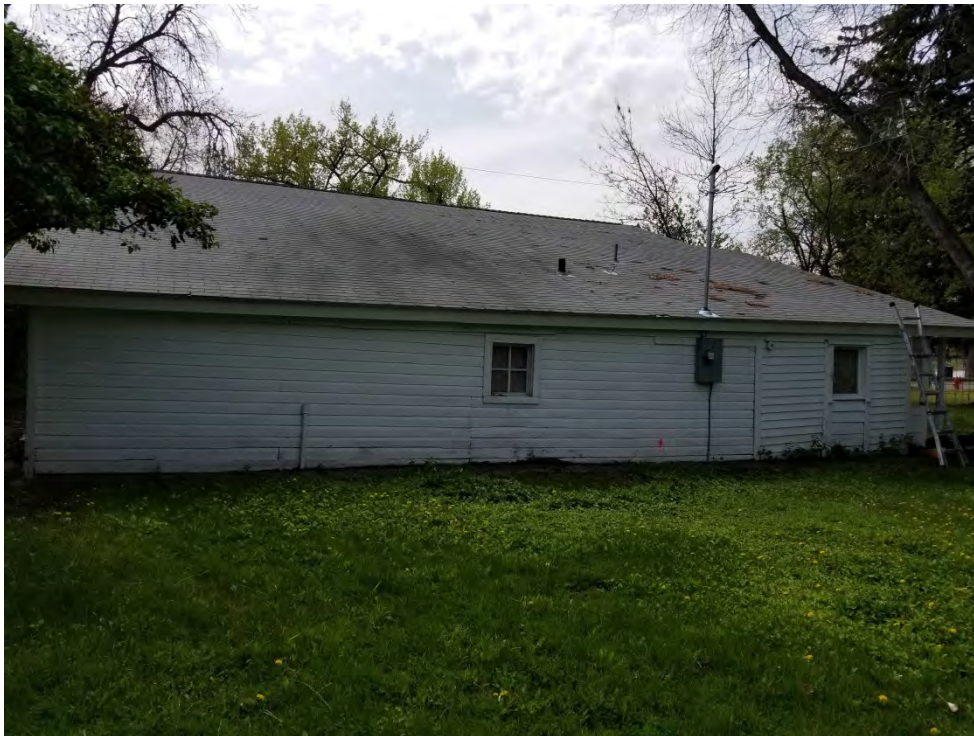
Photo 2

Location:
North Side of Property

Description:
Baker House looking
South. LBP Exterior Siding

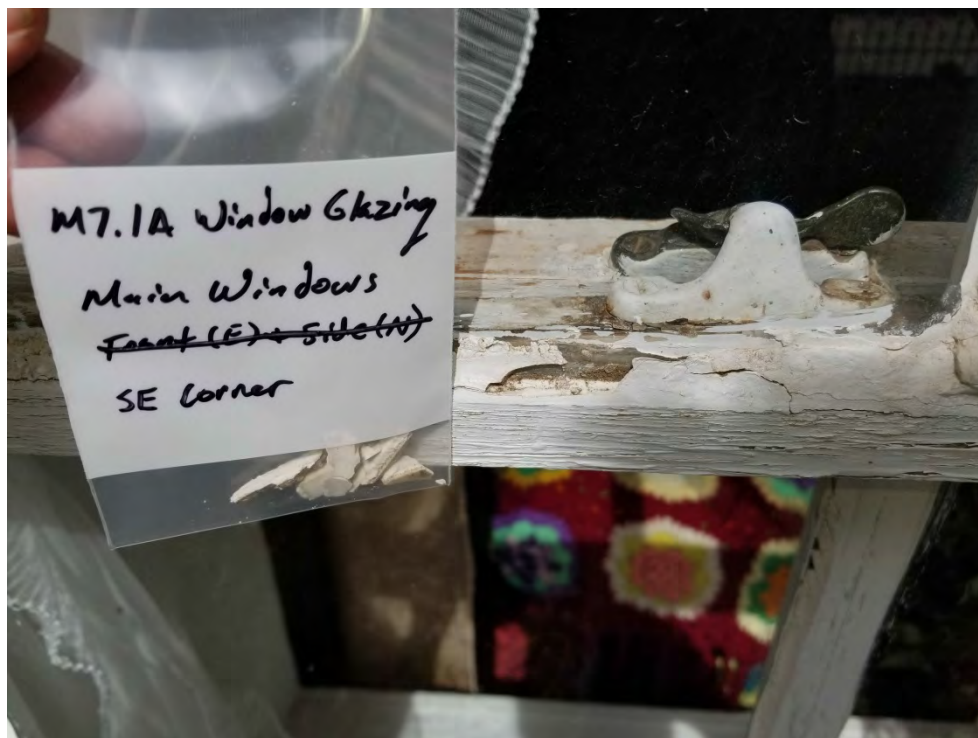
Photo 6

Sample ID	Material Description	Asbestos Type	Asbestos Content	Regulatory Category
F3.1	Green Vinyl Floor Tile (VFT) Mastic	Chrysotile	5%	Category I
M1.3	Joint Compound Patch Material	Chrysotile	3%	RACM
M7.1	Window Glazing	Chrysotile	2%	Category II
M9.1	Beige Ceramic Tile Adhesive	Chrysotile	10%	Category I

Location:
Southeast Corner Window

Description:
Asbestos-Containing
Window Glazing (M7.1)

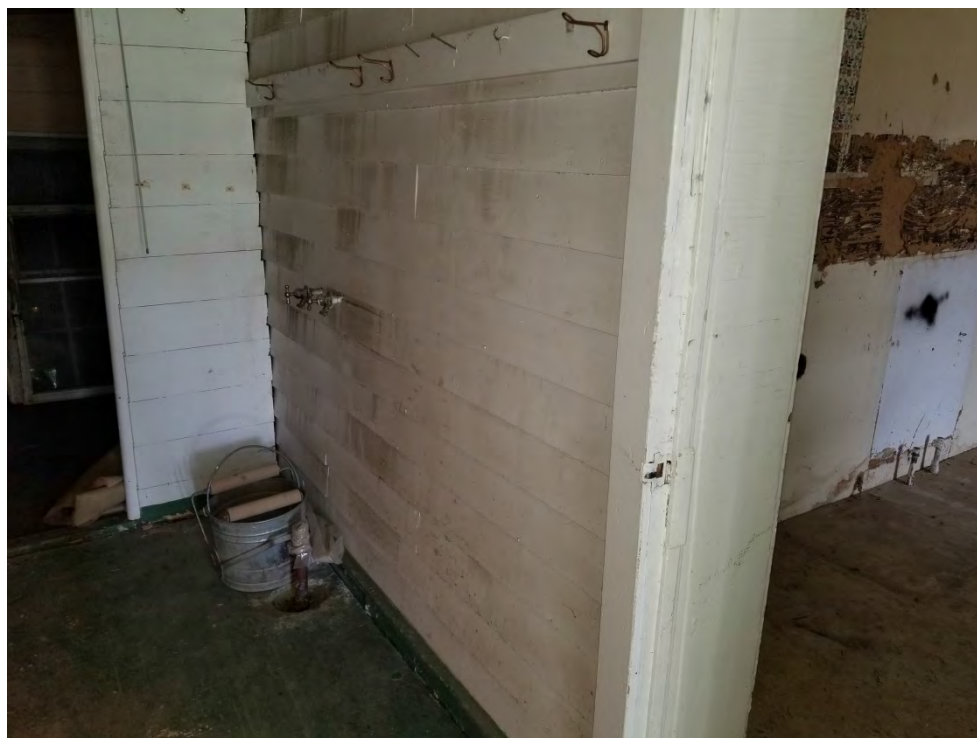
Photo 8

Location:
Vestibule (Back Porch)

Description:
Exterior LBP Wall and
Door Casing

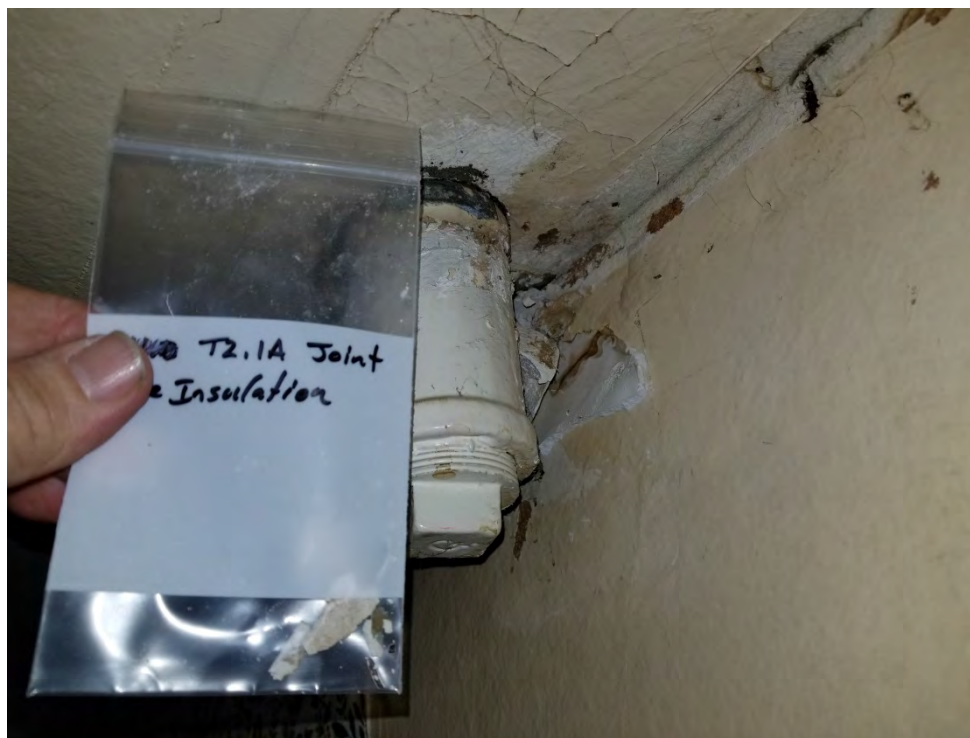
Photo 10

Location:
Kitchen Ceiling

Description:
Pipe Joint Insulation Patch
Material (<6 sq ft)

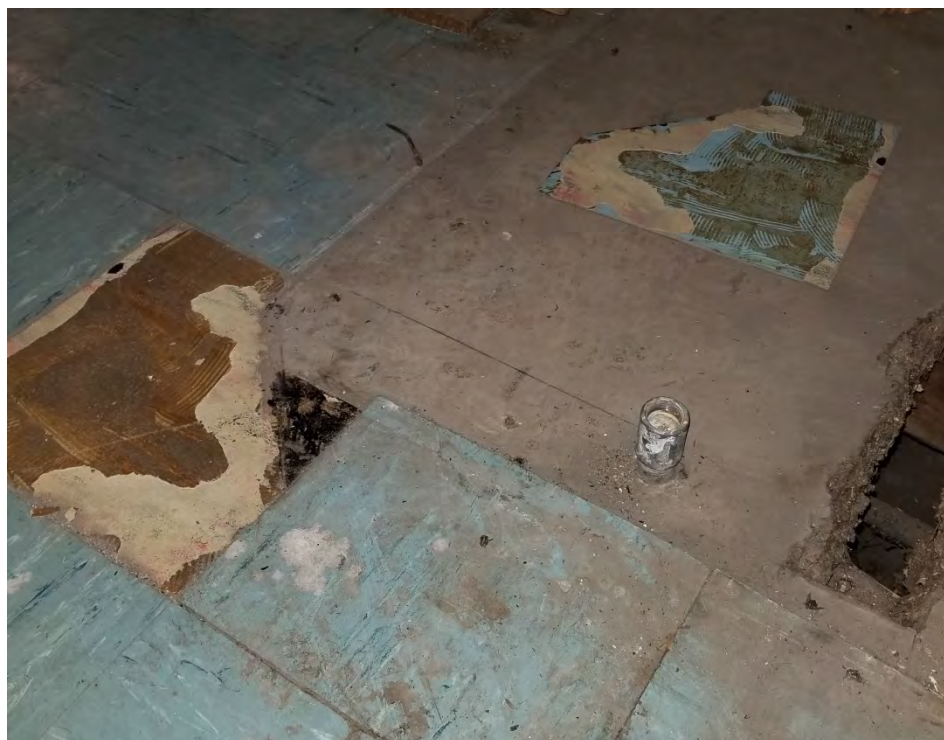
Photo 11

Location:
Bathroom

Description:
9-inch Vinyl Floor Tile and
Asbestos-Containing Mastic (F3.1)

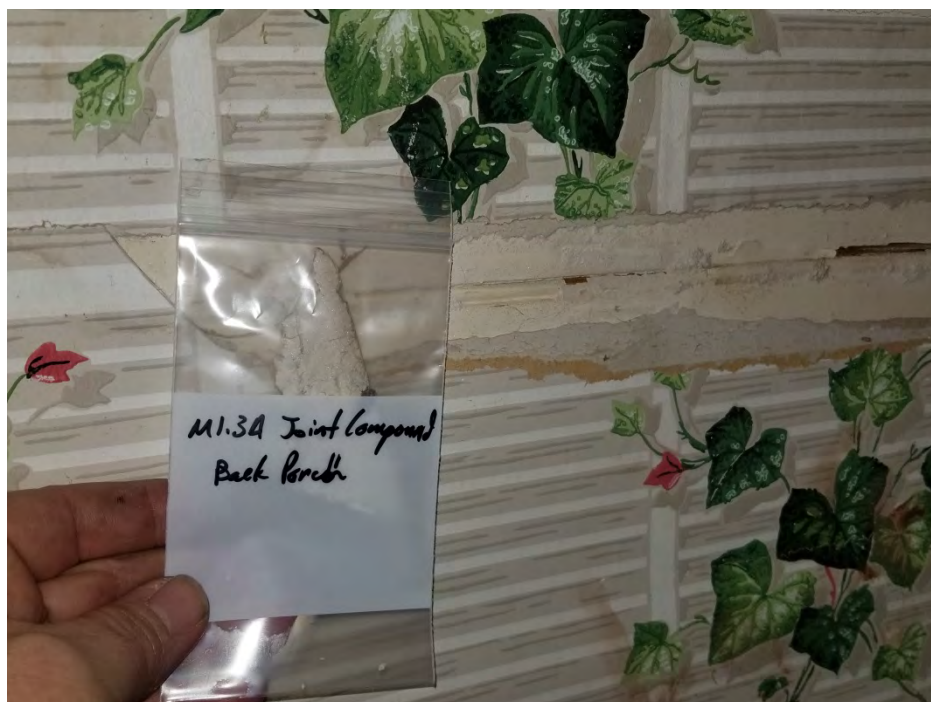
Photo 12

Location:
Vestibule (Back Porch)

Description:
Asbestos-Containing Joint
Compound on Wood (M1.3)

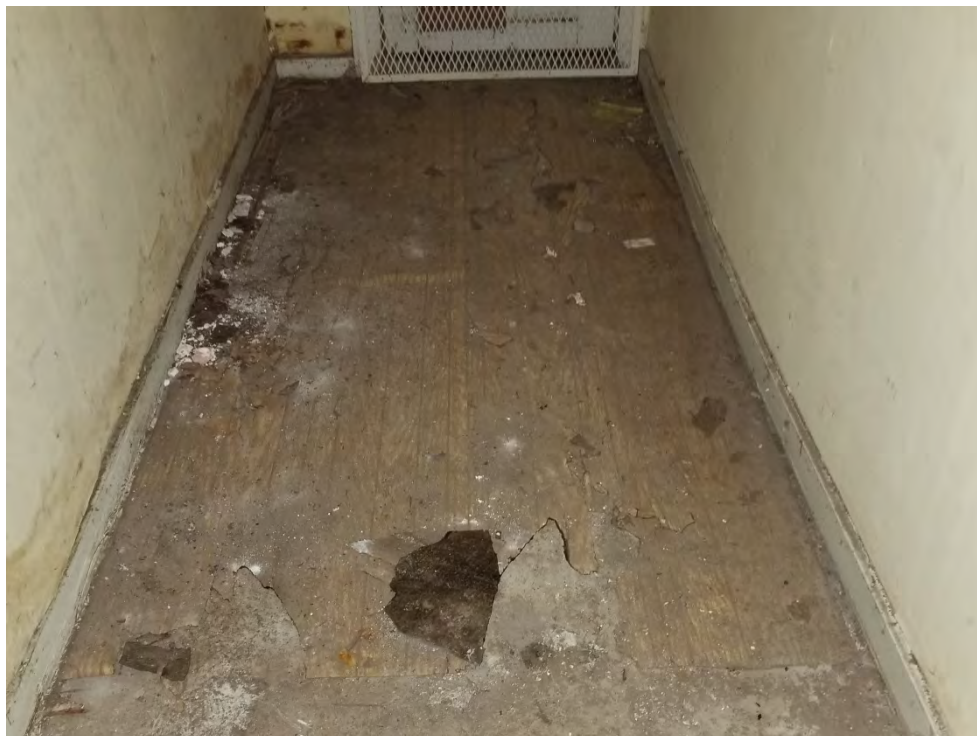
Photo 14

Location:
Northwest Corner Porch

Description:
Non-Asbestos Vinyl Sheet
Flooring (F1.2) and Yellow
LBP on Walls/Ceiling

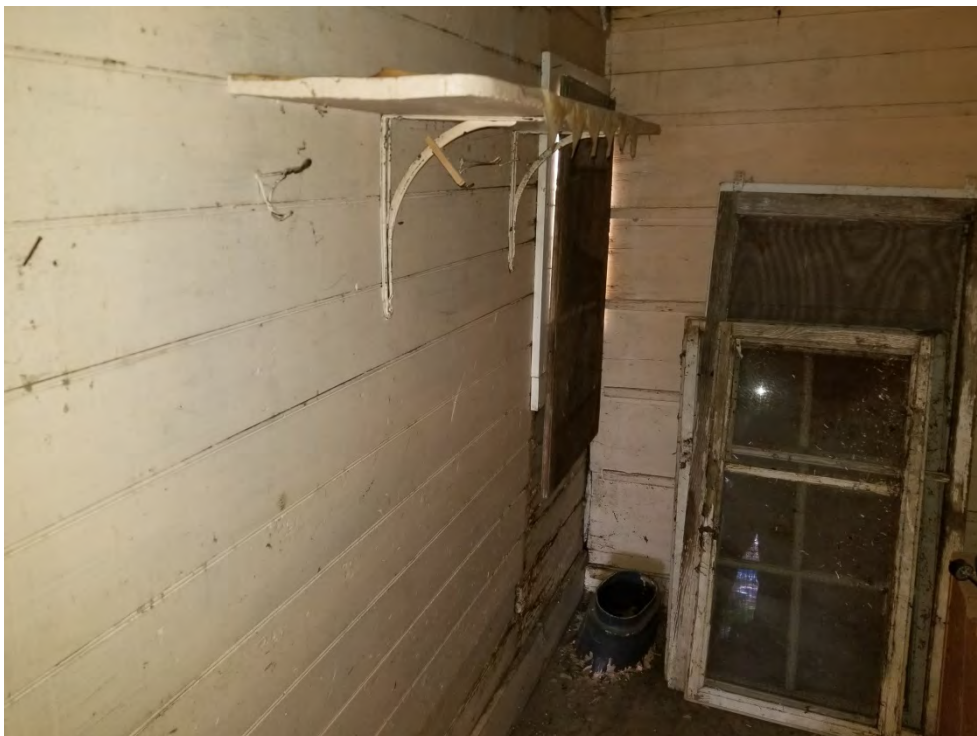
Photo 16

Location:
Vestibule (Back Porch)

Description:
Stored Window Systems
and LBP Walls/Ceiling
